# INDIAN ARCHAEOLOGY

2011-12 – A REVIEW

**PUBLISHED BY THE DIRECTOR GENERAL  
ARCHAEOLOGICAL SURVEY OF INDIA  
JANPATH, NEW DELHI-110011  
2016**

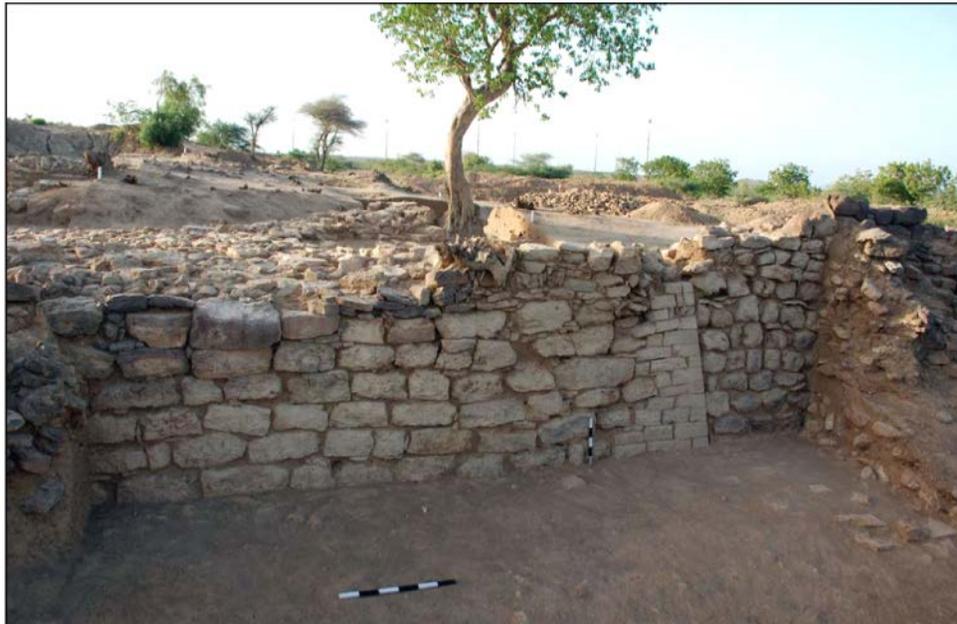
*Khirsara: A, southern fortification wall of the citadel and B, steps leading to the pathway.*

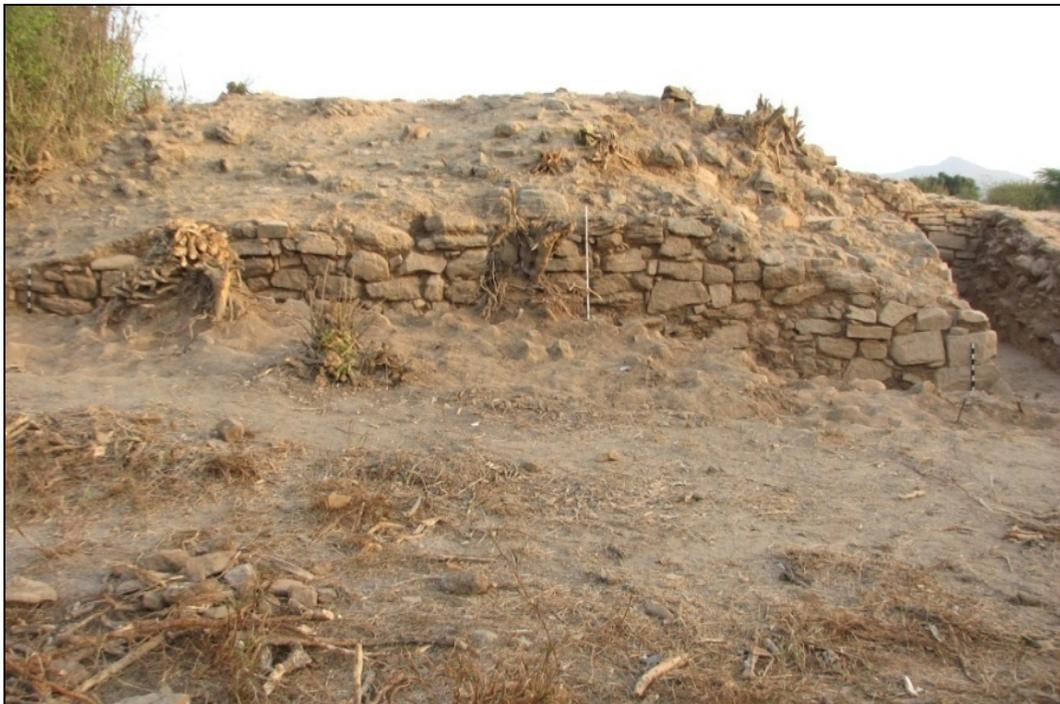
*Kotada Bhadli: view of bastion from, A, east and B, south*

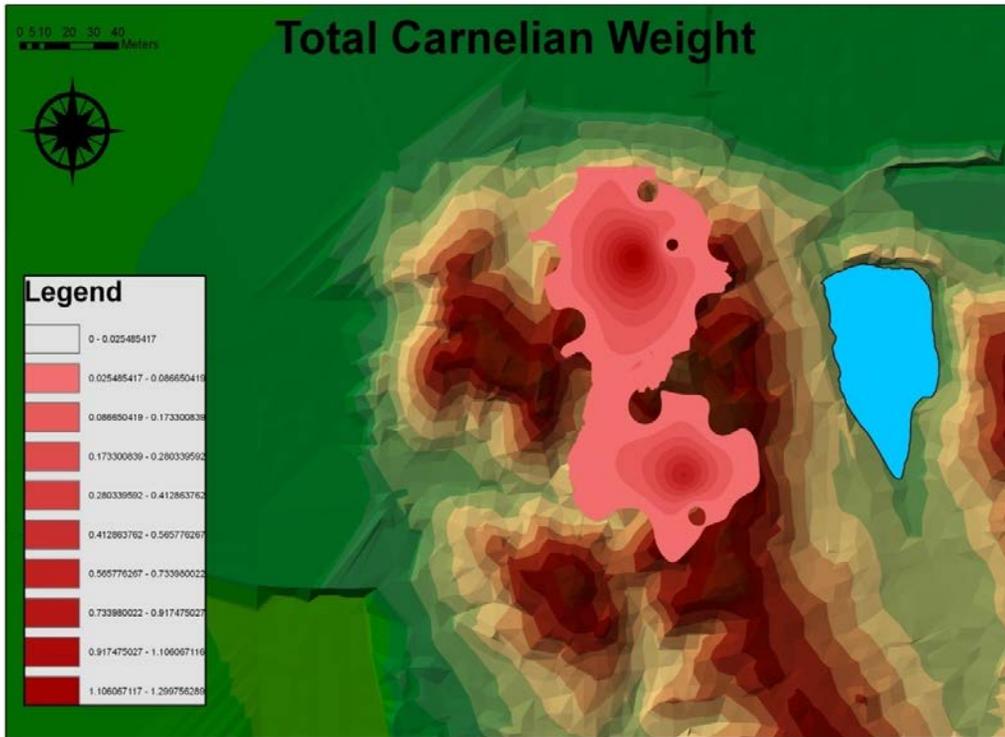
Fig.13

Rakhigarhi: 13, distribution of carnelian on RGR 2 and 14, location of profiles on RGR2

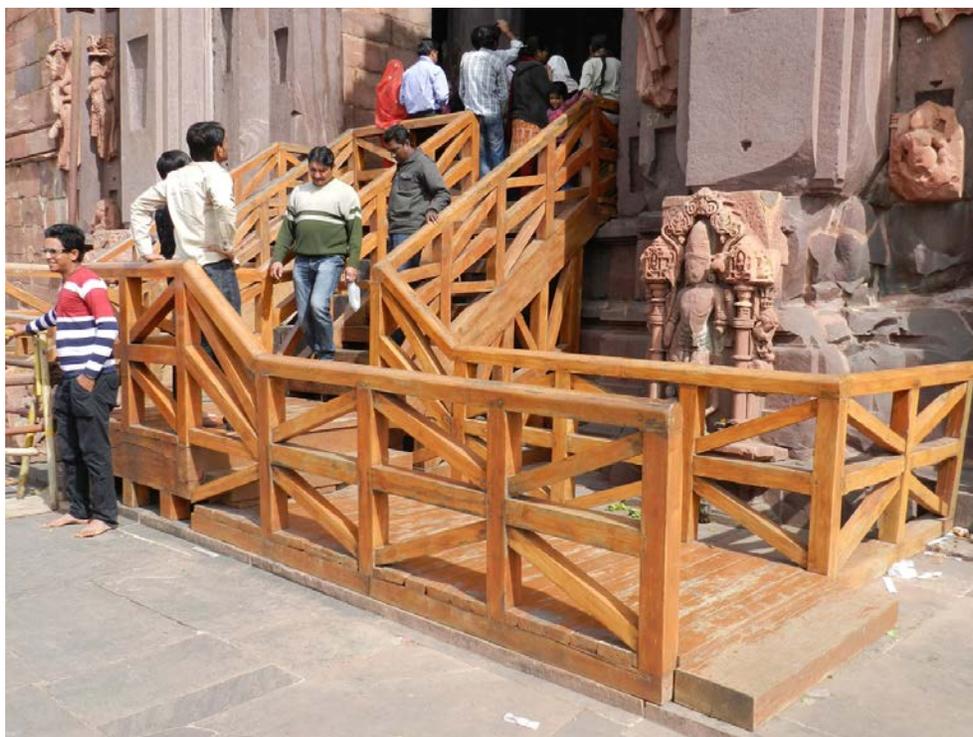
*A, Yashodharman's Victory Pillar, Mandsaur: sand stone flooring and B, Siva Temple, Bhojpur: wooden-staircases*

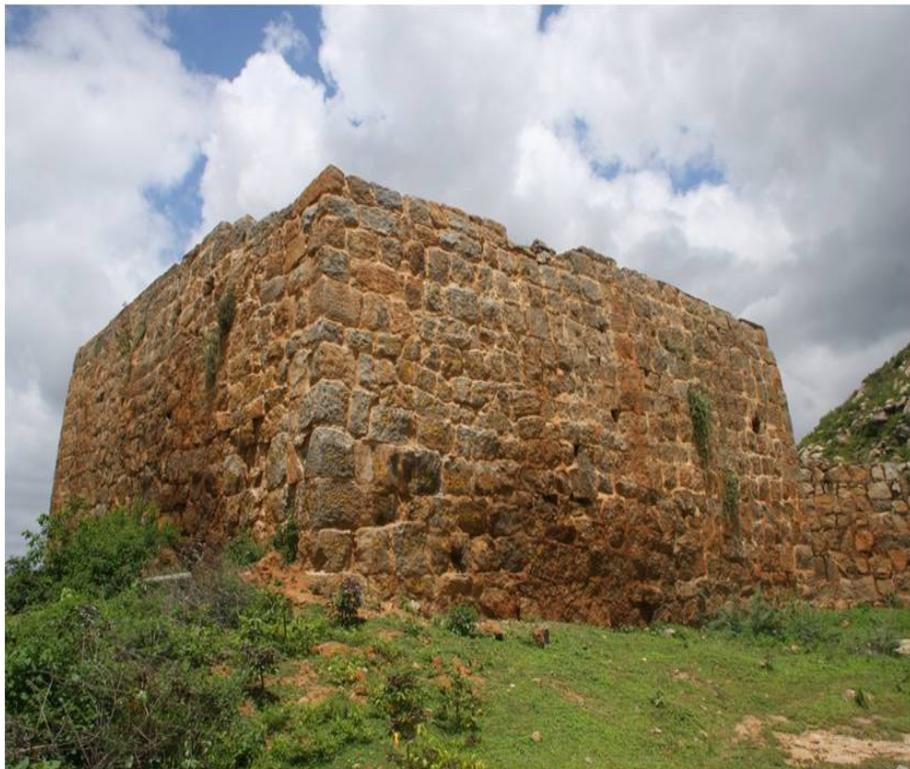
*Hill Fort, Ratnagiri: A, before and B after conservation of damaged bastion wall*

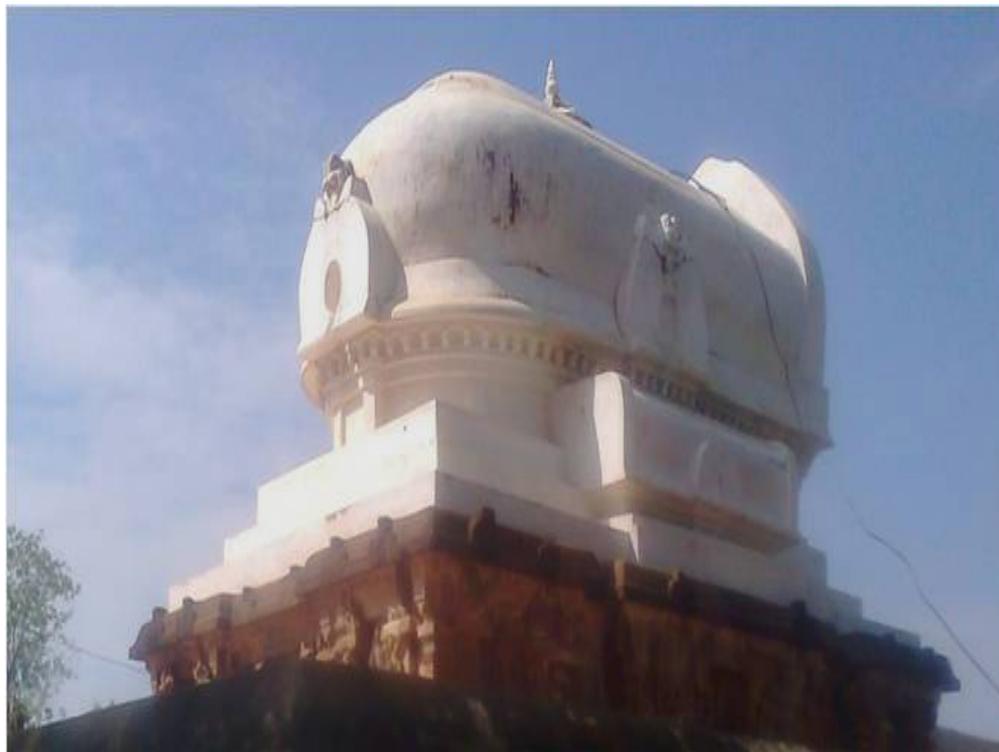
*Sri Parsurameswara Temple, Polilur: A, before and B, after conservation of the Vimana*

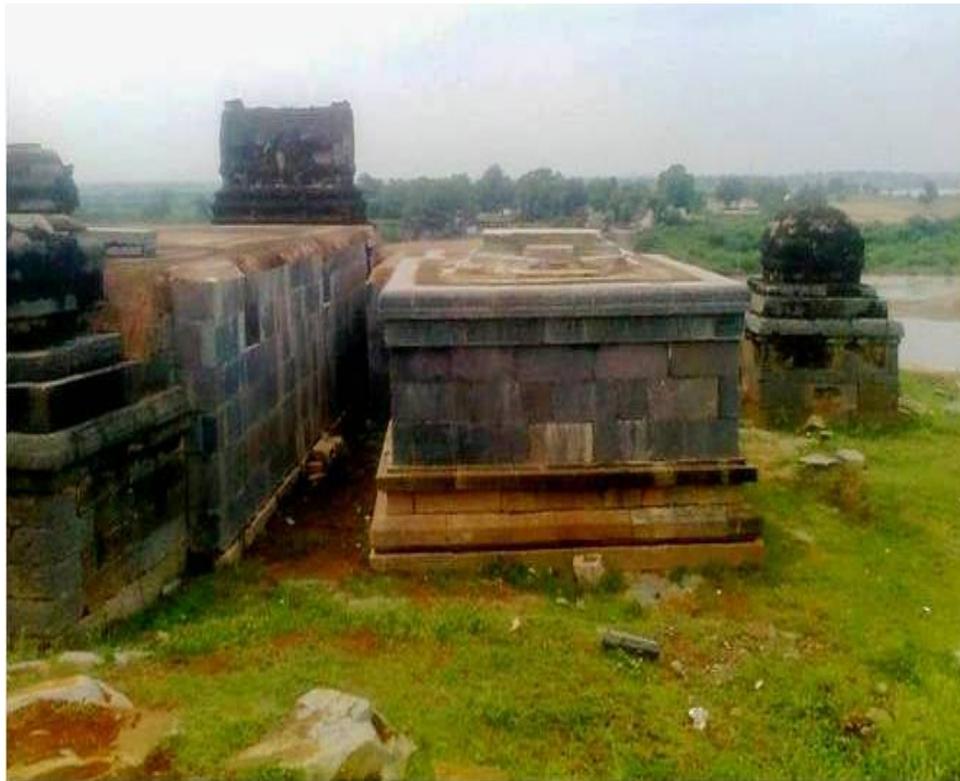
*Sri Kamalasambaveswara Swamy temple, Pushpagiri: A, before and B, after conservation*

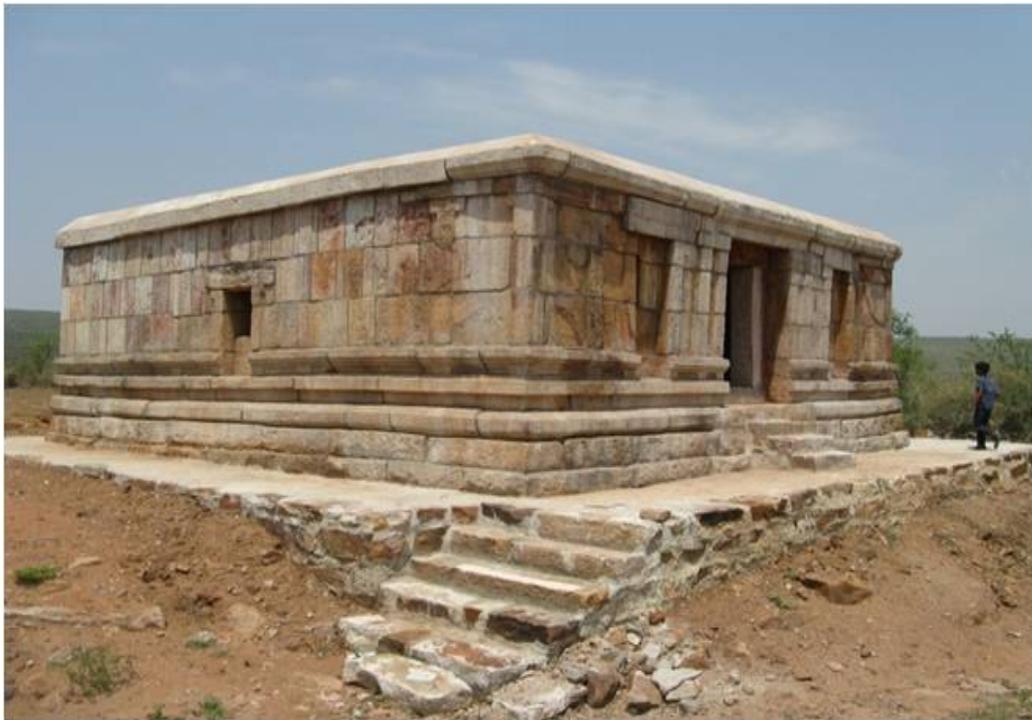
*Gandikota Fort, Cuddapah: A, before and B, after conservation of Mandapa*

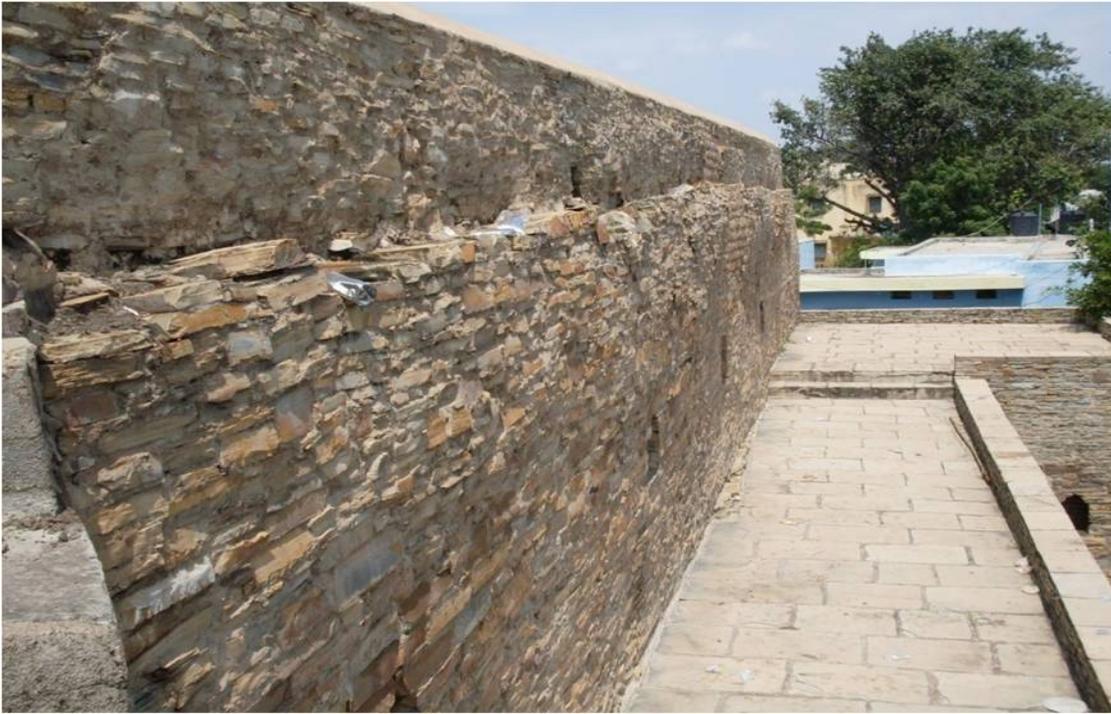
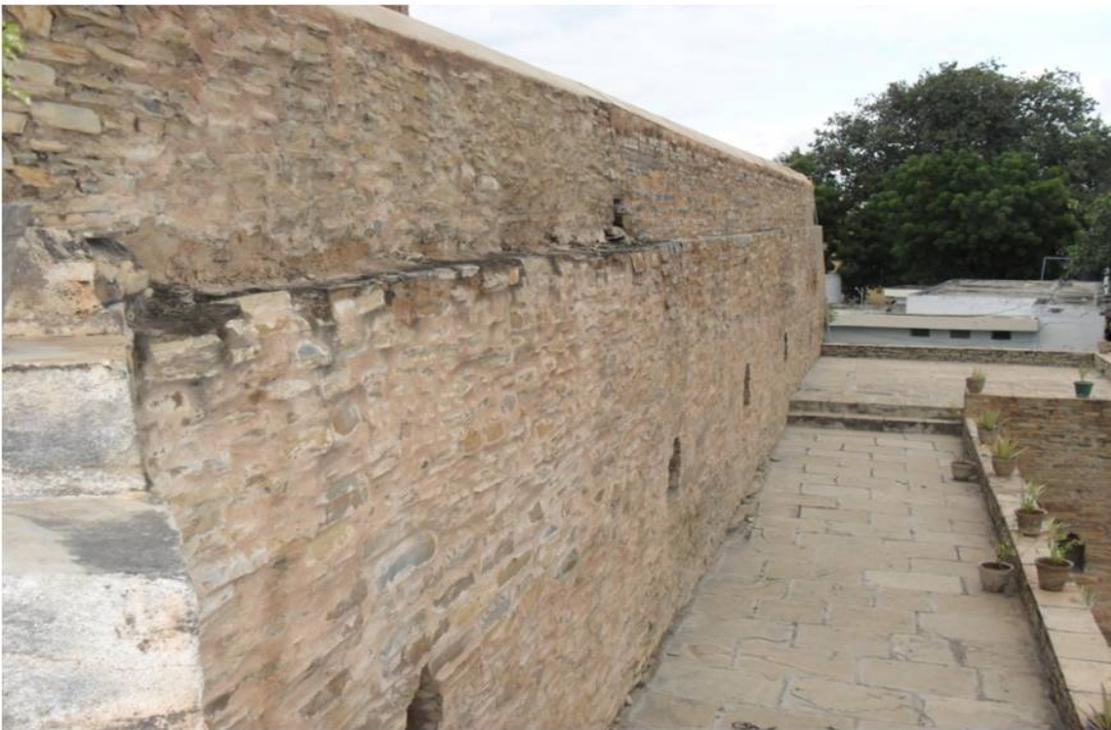
*Konda Reddy Burz, Kurnool: A, before and B, after conservation of the wall*

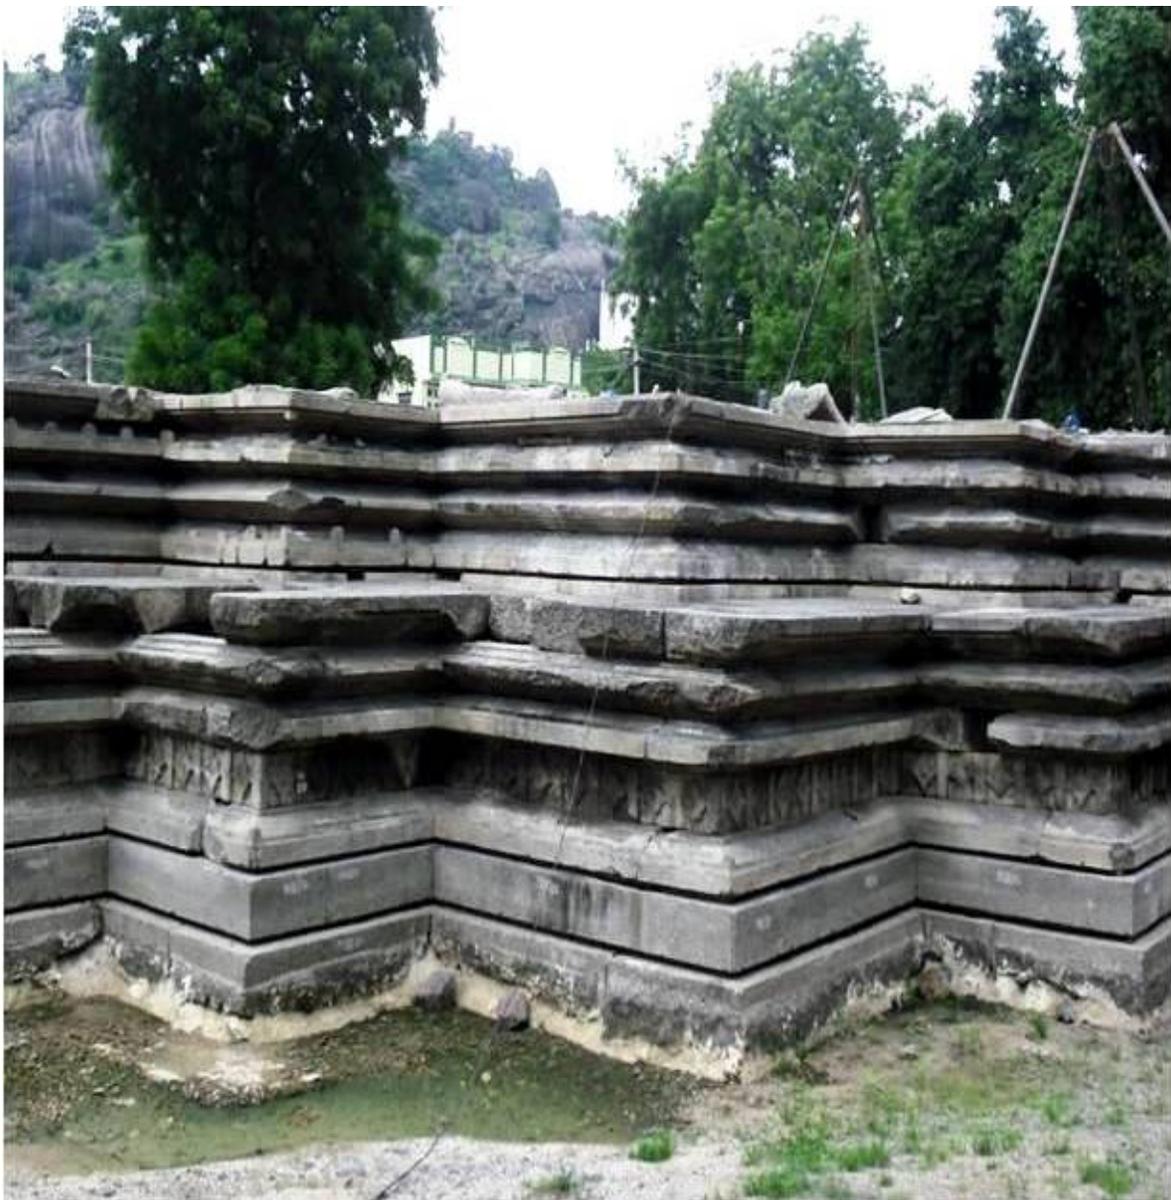
*Thousand Pillared Temple, Hanumakonda: during resetting of Kalyanamandapa*

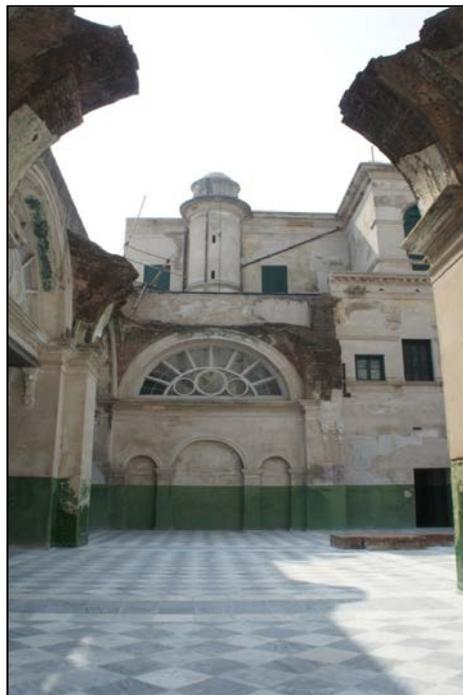
*Currency Building, Kolkata: A, before and B, after repairing*
