INDIAN ARCHAEOLOGY 2010-11 - A REVIEW

ARCHAEOLOGICAL SURVEY OF INDIA
JANPATH, NEW DELHI

INDIAN ARCHAEOLOGY 2010-2011 – A REVIEW

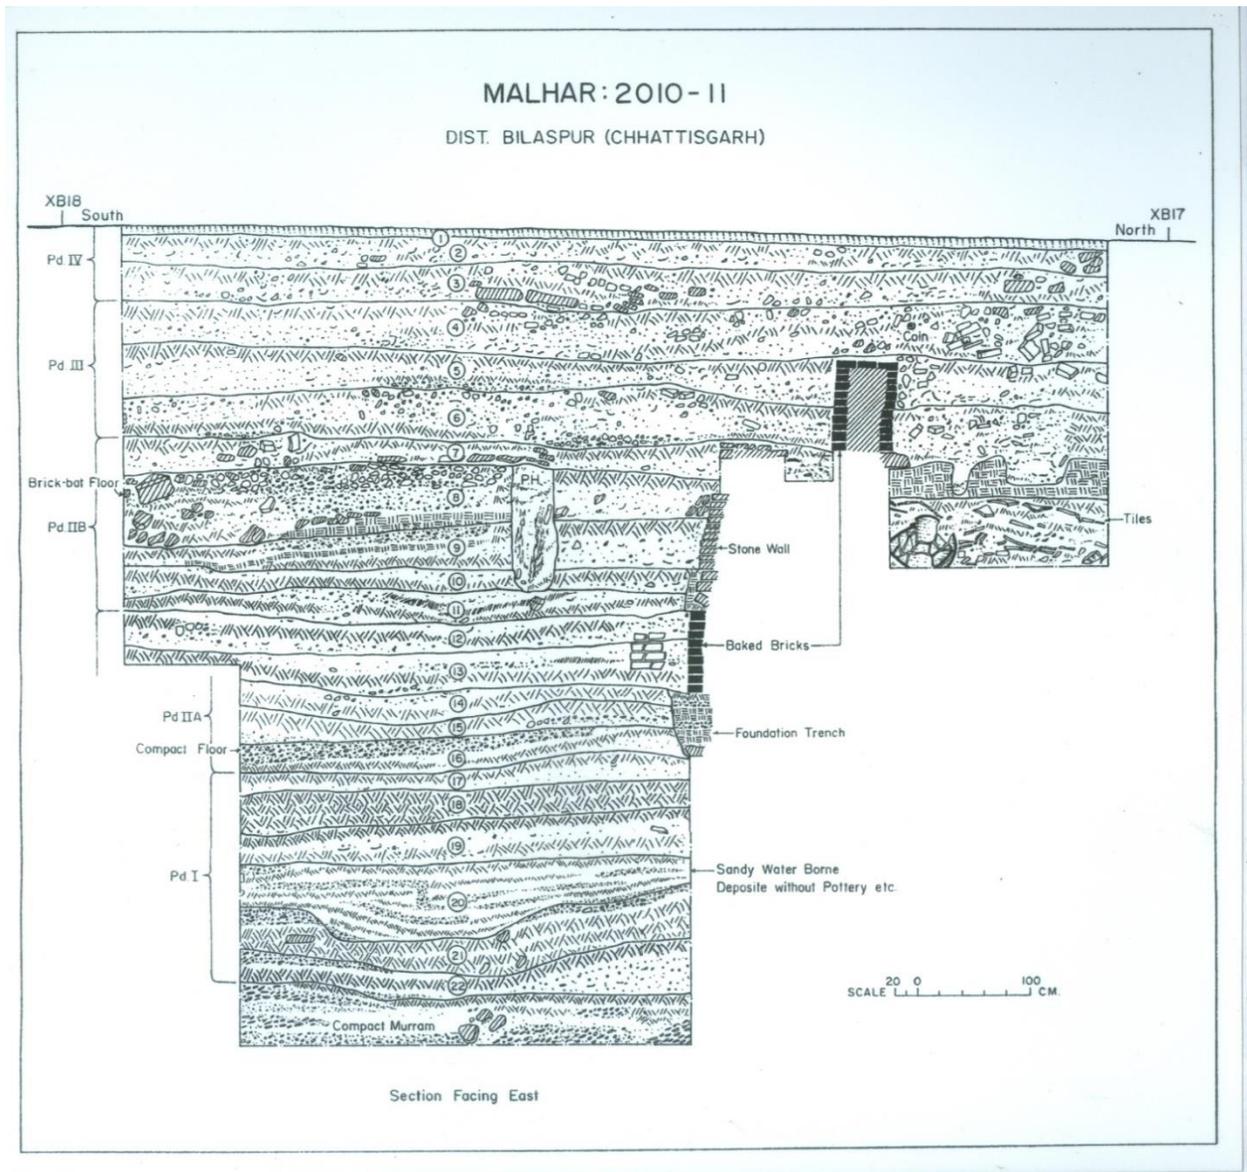
Fig. 2

Excavated section and structures from different periods

This season, the excavation has yielded approximately four periods of deposit, encountering nearly twenty two layers of occupation with an evidence of flood that has caused complete erosion of the site at the twentieth layer of habitation (Fig. 2).

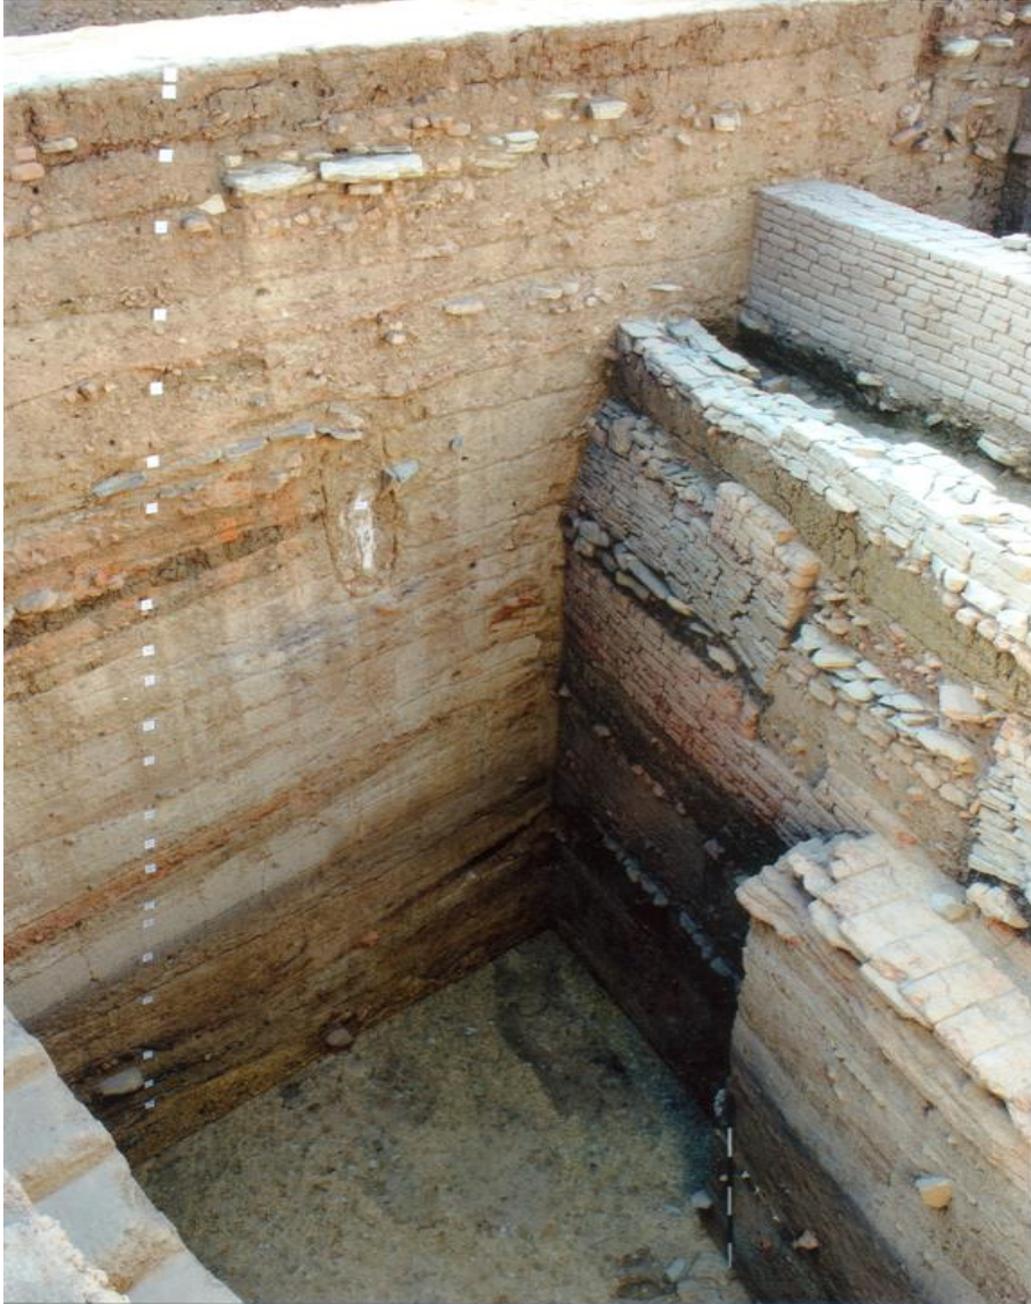
Malhar: Excavated section and structures from different periods- view from east

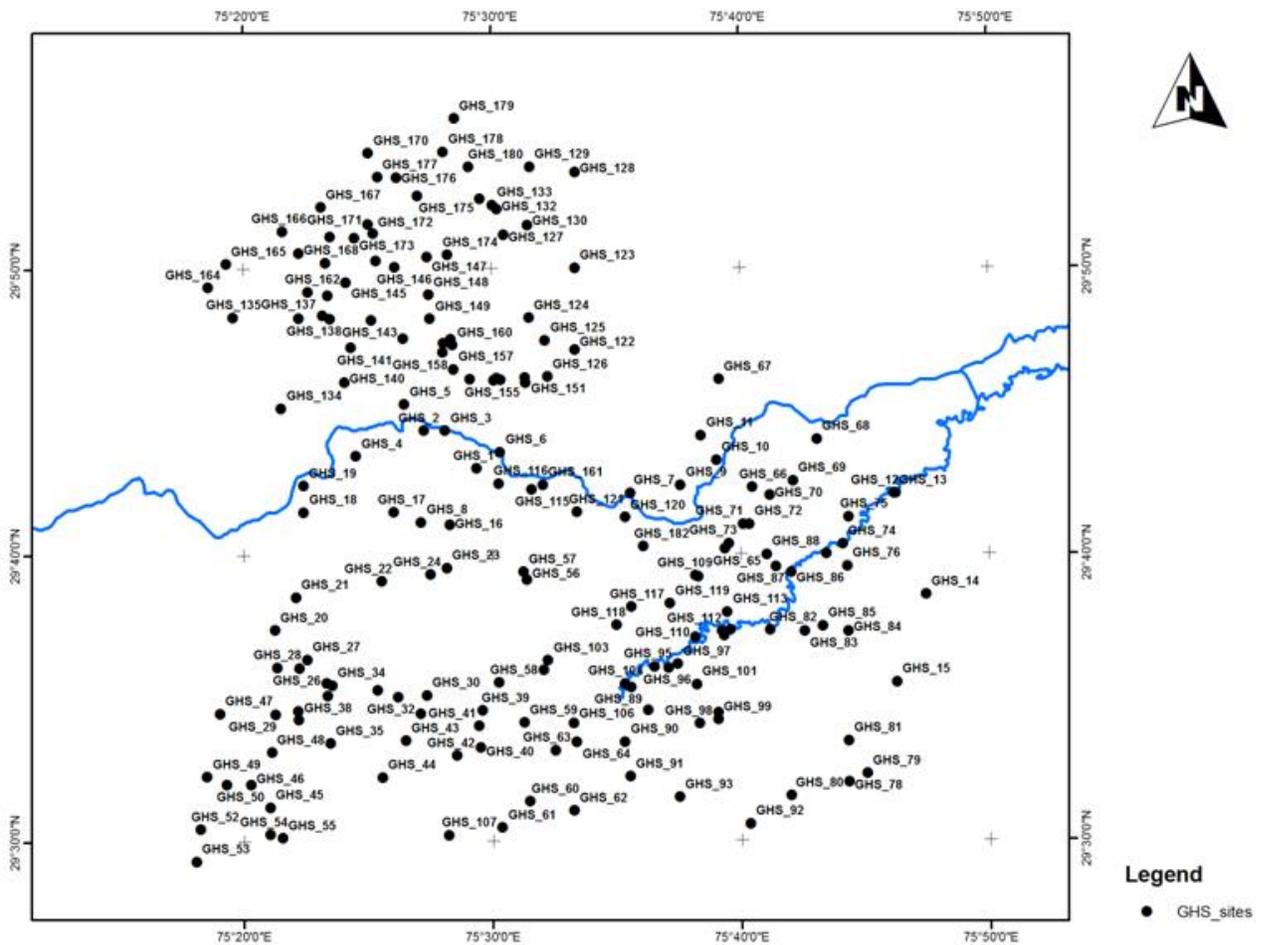
Fig. 3

Distribution of sites found in relation to the course of the modern Ghaggar (above) and the Rangoi nullah (below)

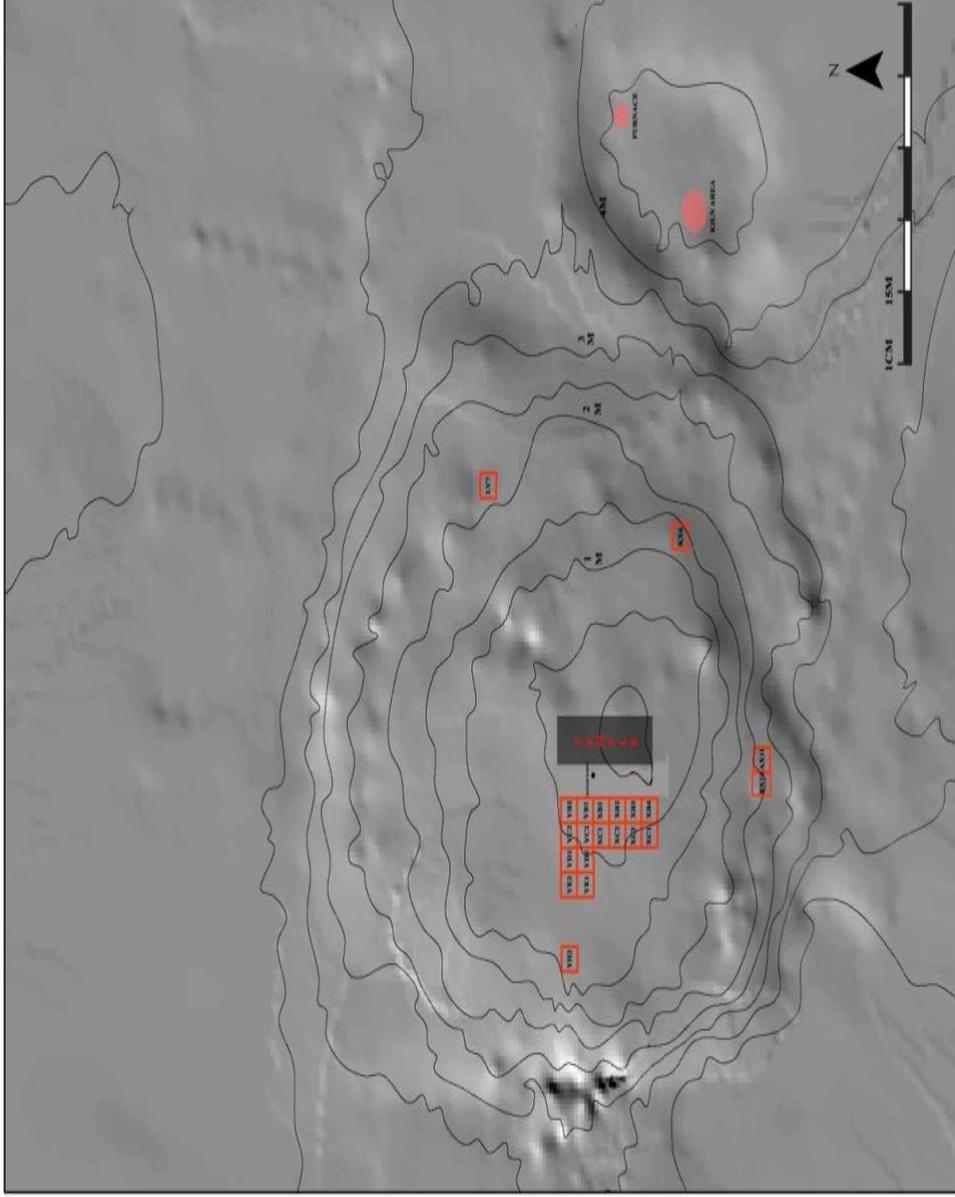
Fig. 5

Digital Elevation Model of Karsola Kheda, with the location of trenches and modern temple marked

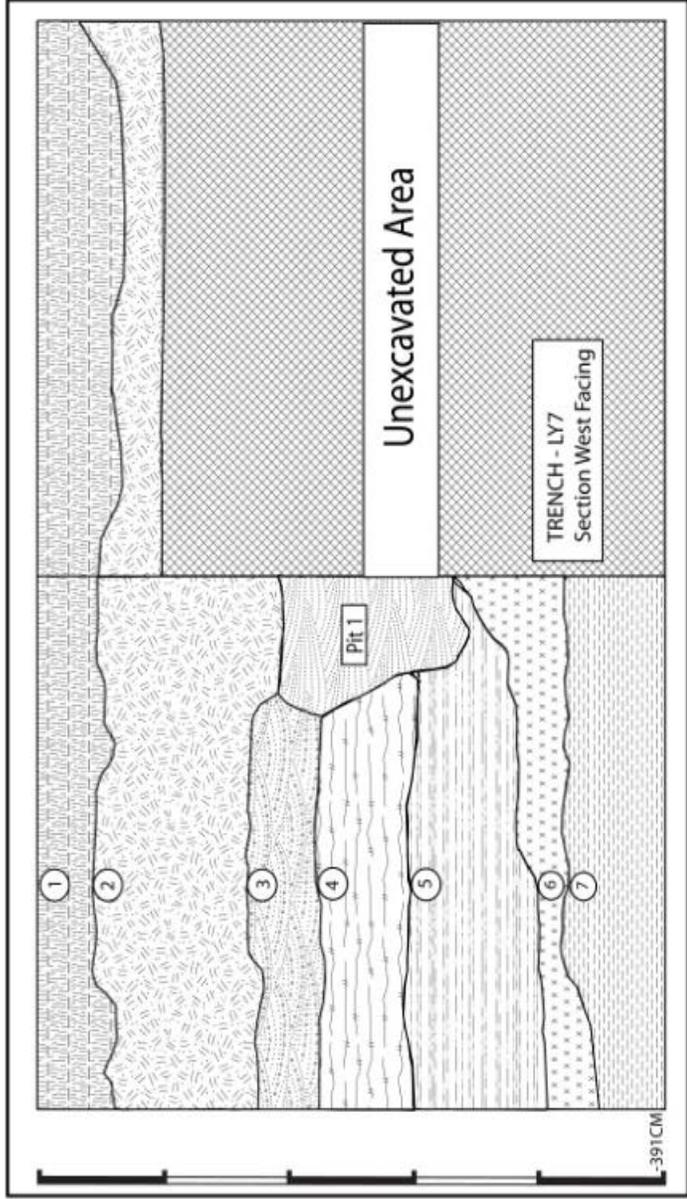
Fig. 6

Section of LY7, illustrating the stratigraphic sequence

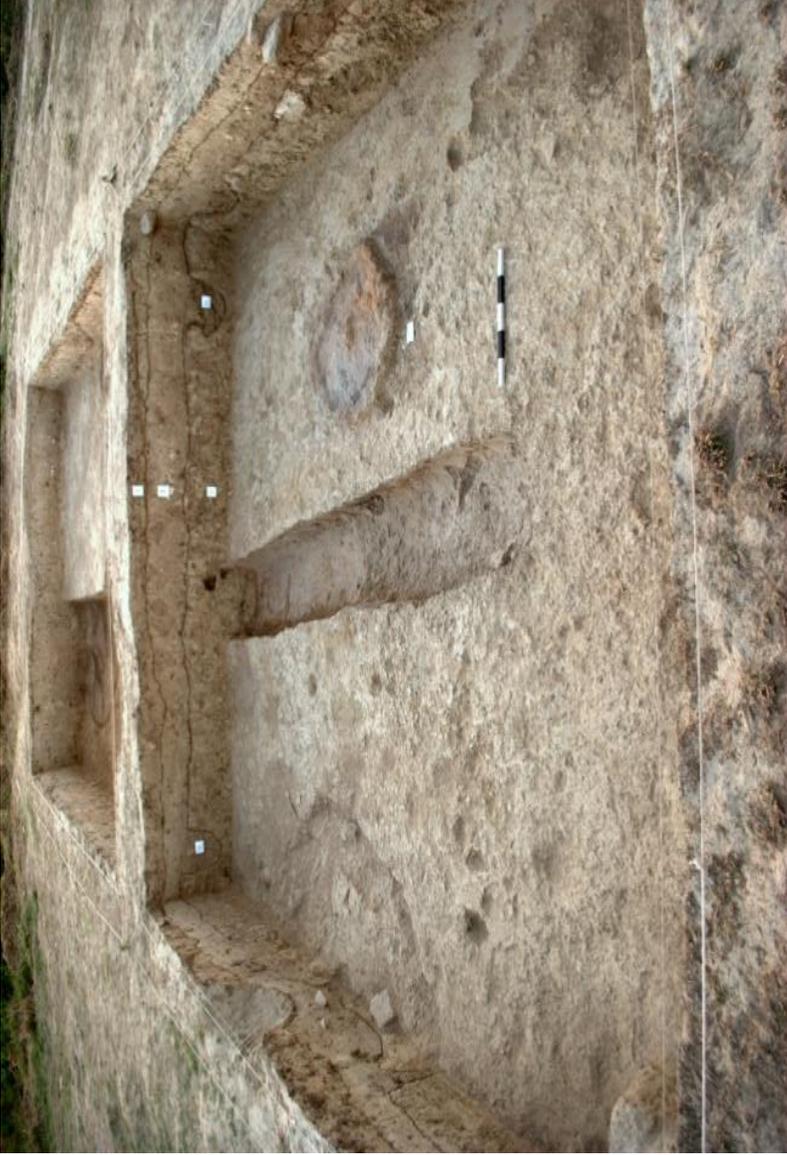
Karsola: A circular furnace and a water container to its south in Trench BX II

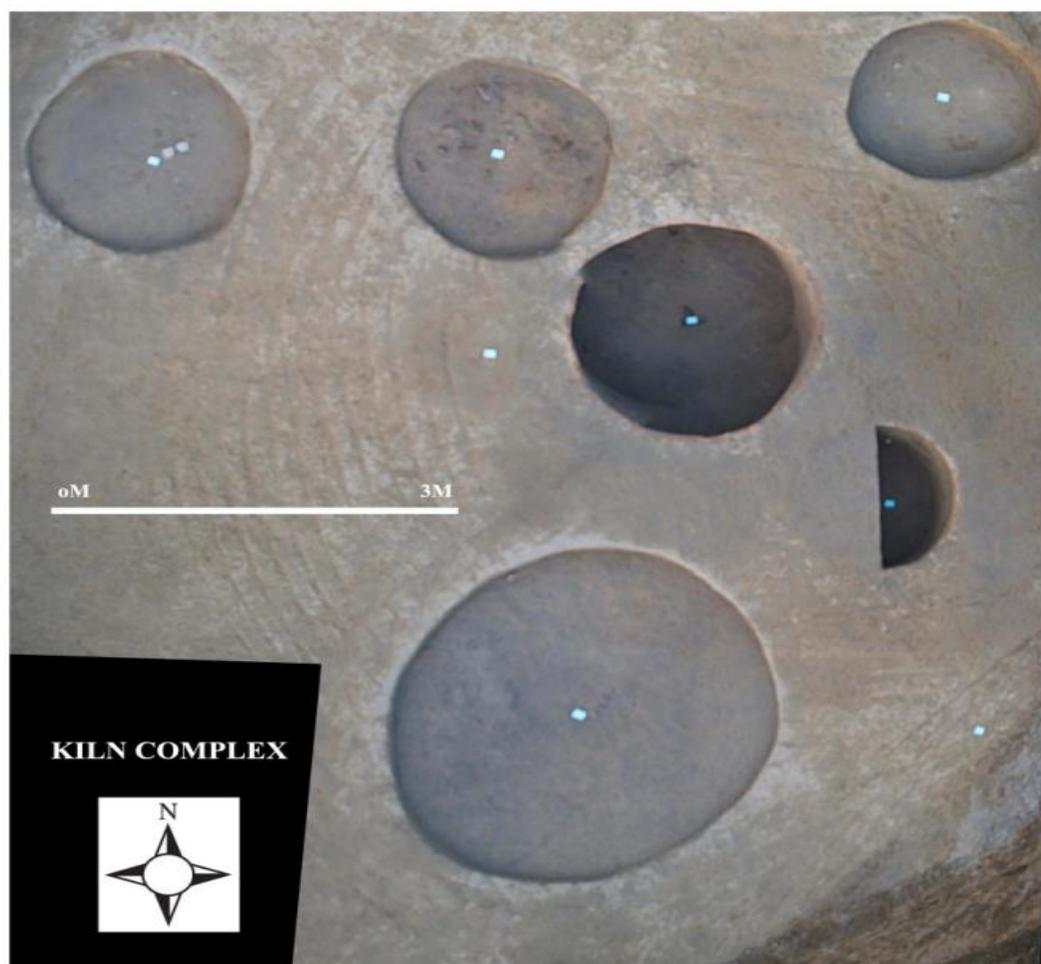
Fig. 7

Karsola: Location of six pits forming a part of a kiln complex rescued from the field

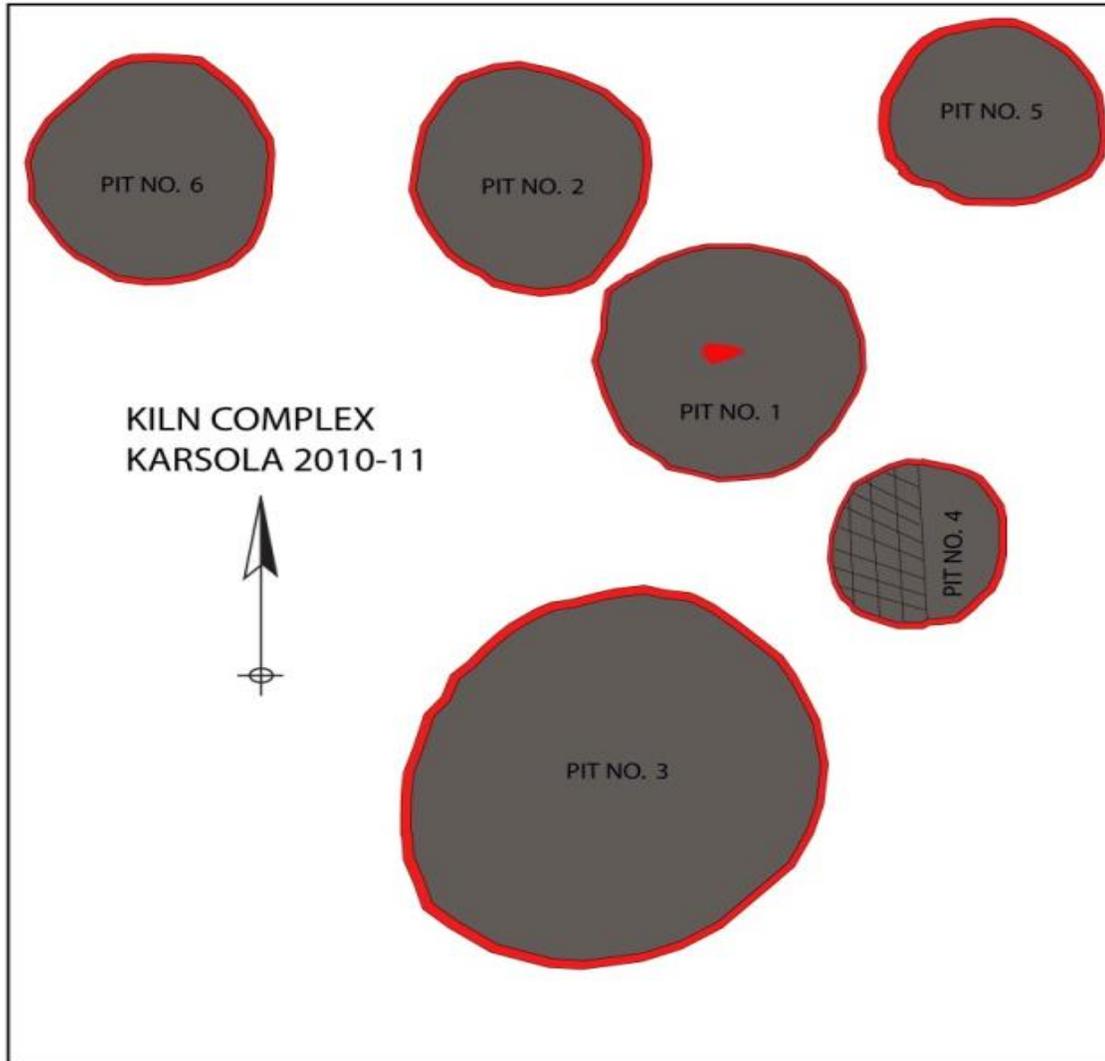
Fig. 8

*Details of the kiln complex*

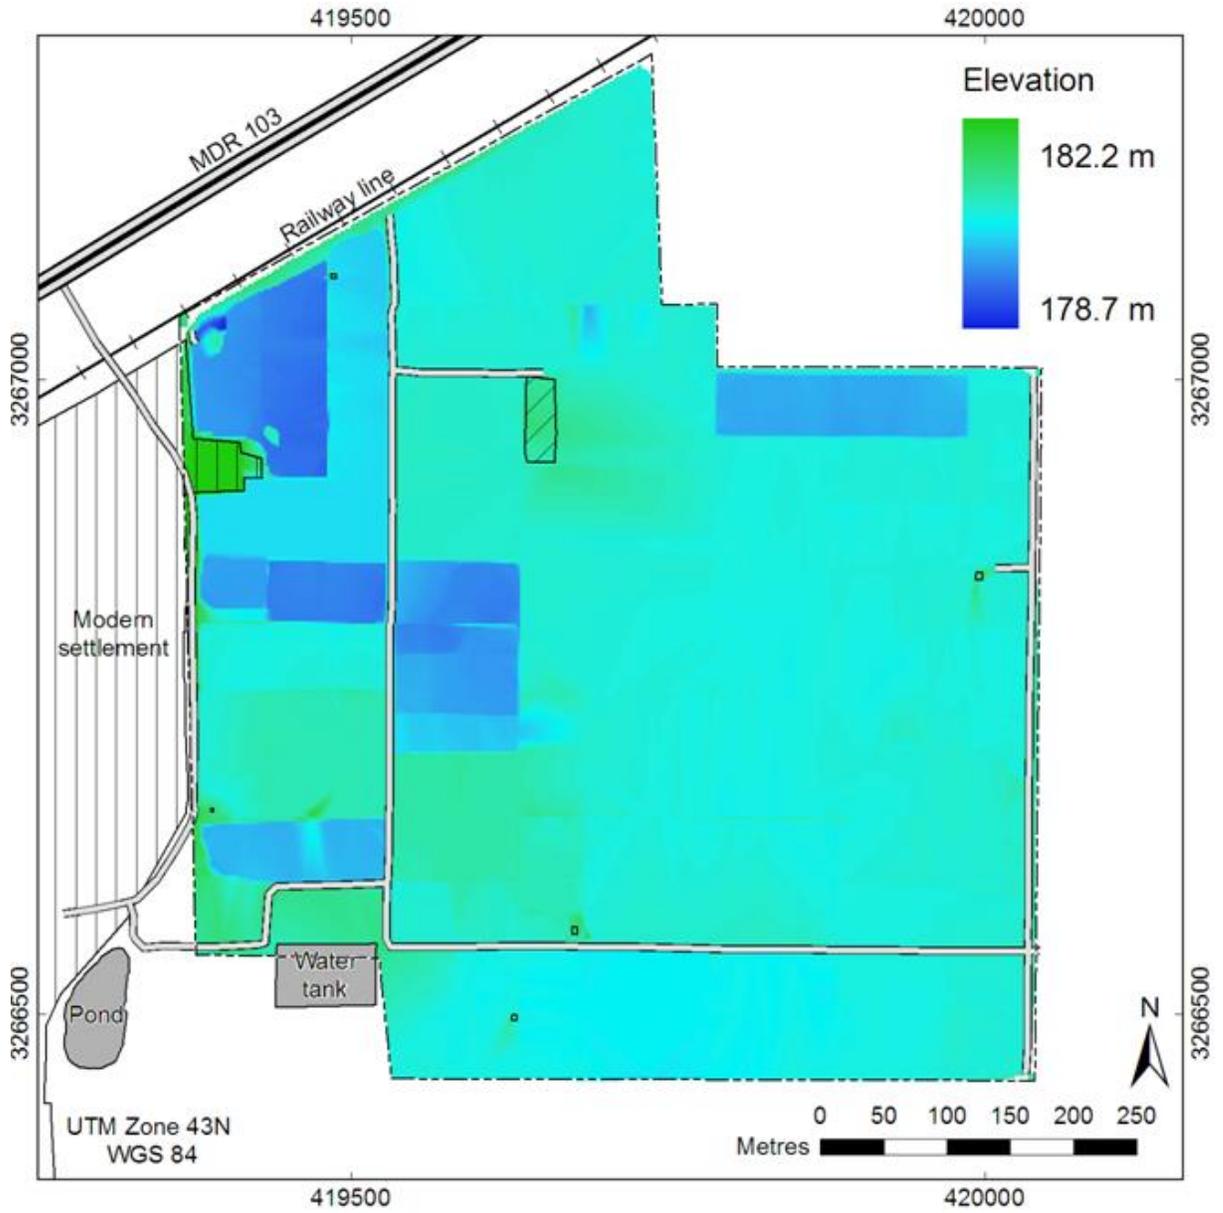
Fig. 10

Contour plan of Dabli vas Chugta

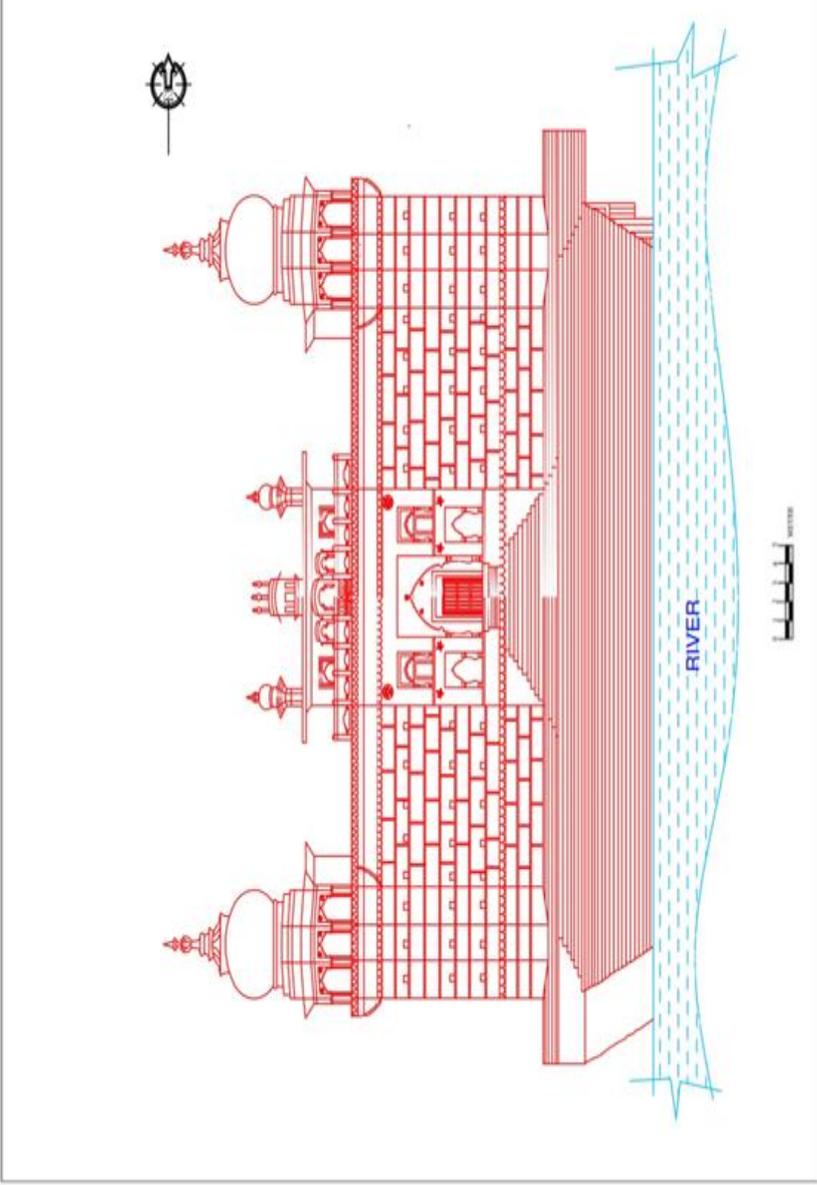
Fig. 16

Varanasi: front elevation of Chet Singh Ghat

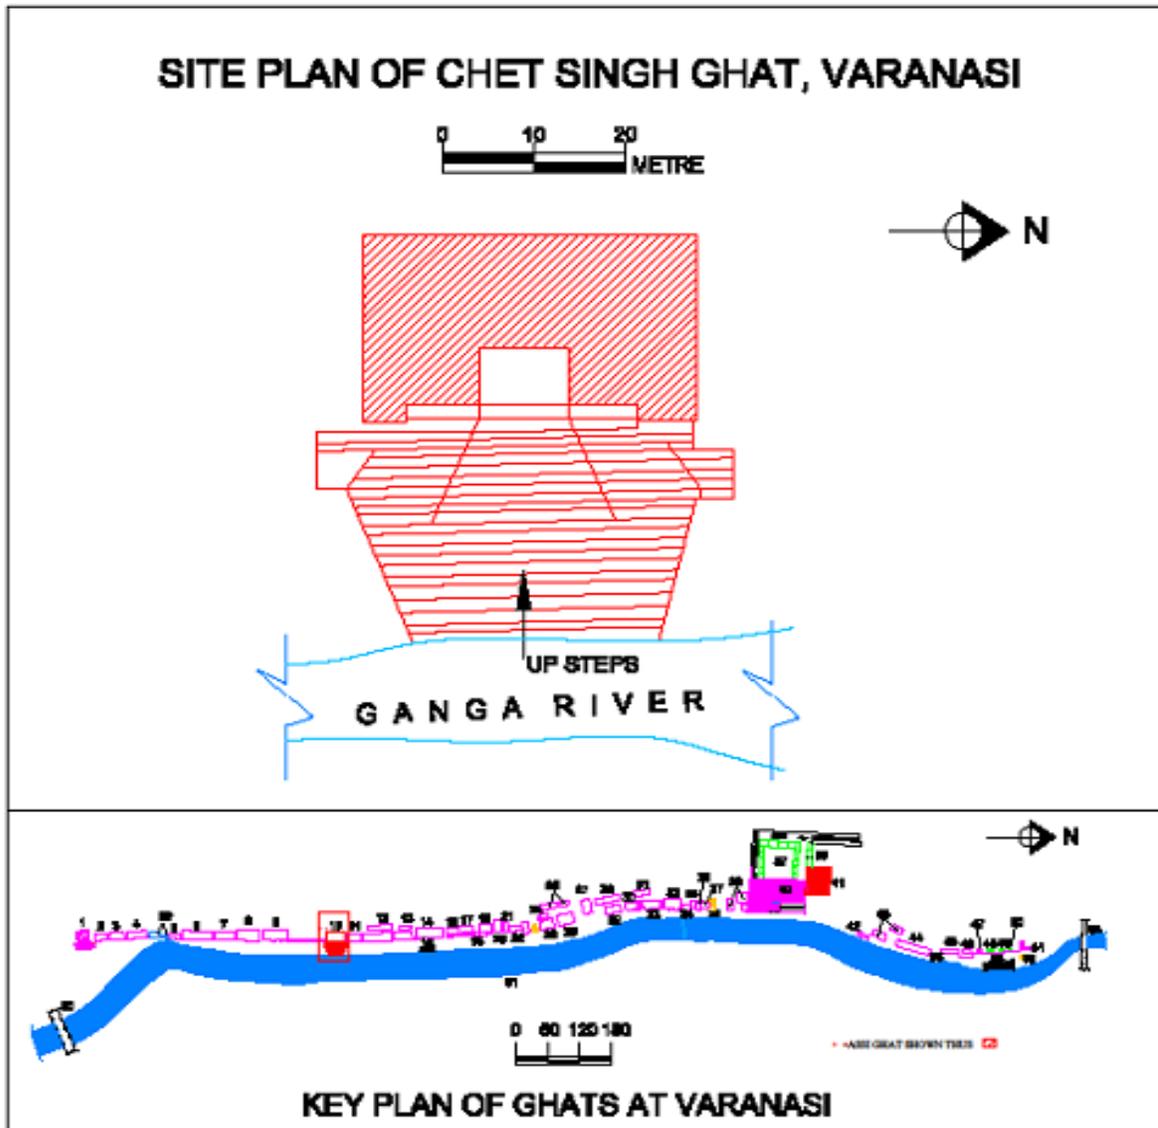
Fig. 17

Varanasi: Site plan of Chet Singh Ghat and key plan of the Ghats

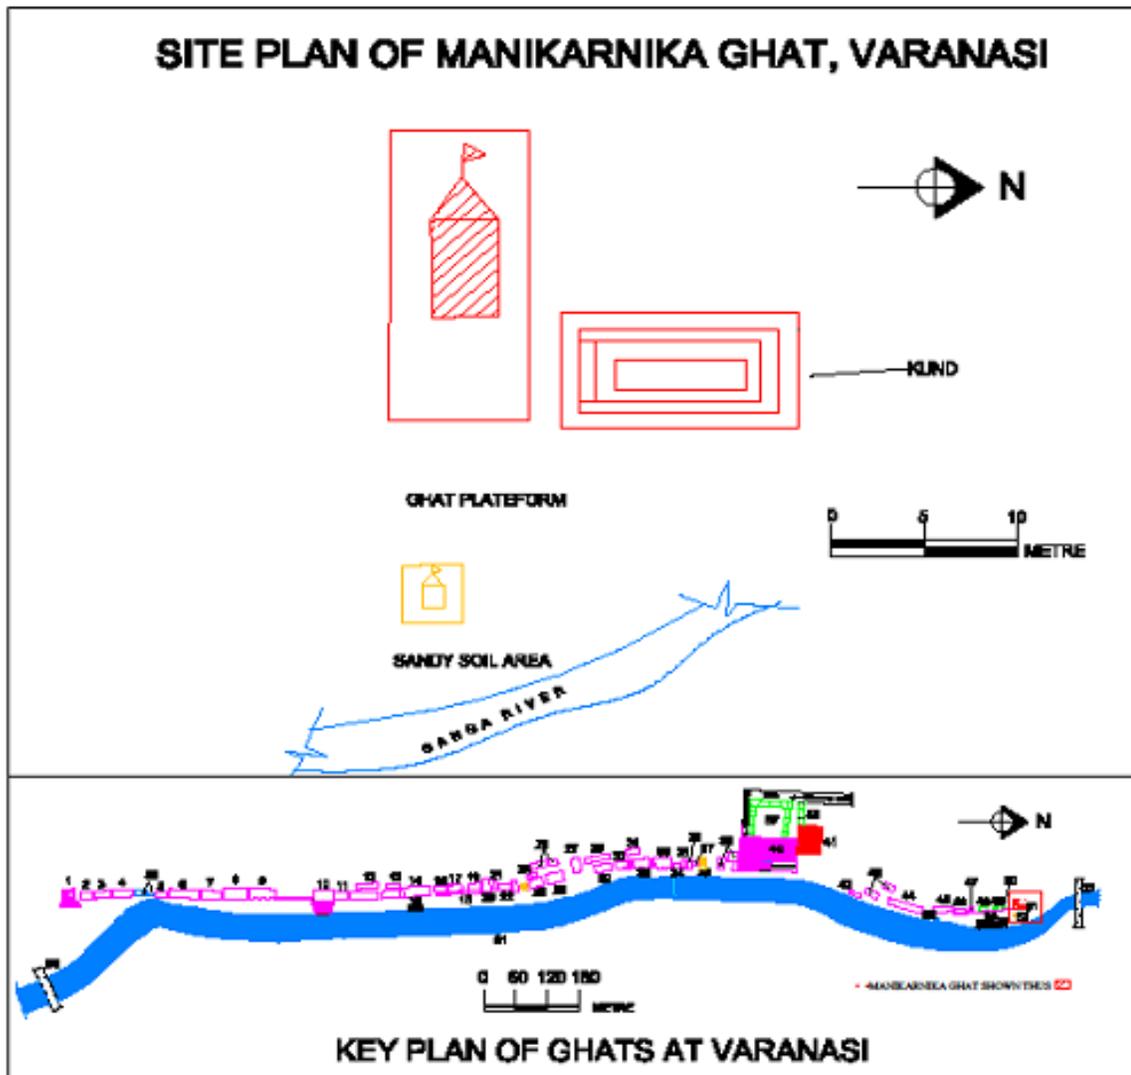
Fig. 18

Varanasi: Site plan of Manikarnika Ghat and key plan of the Ghats

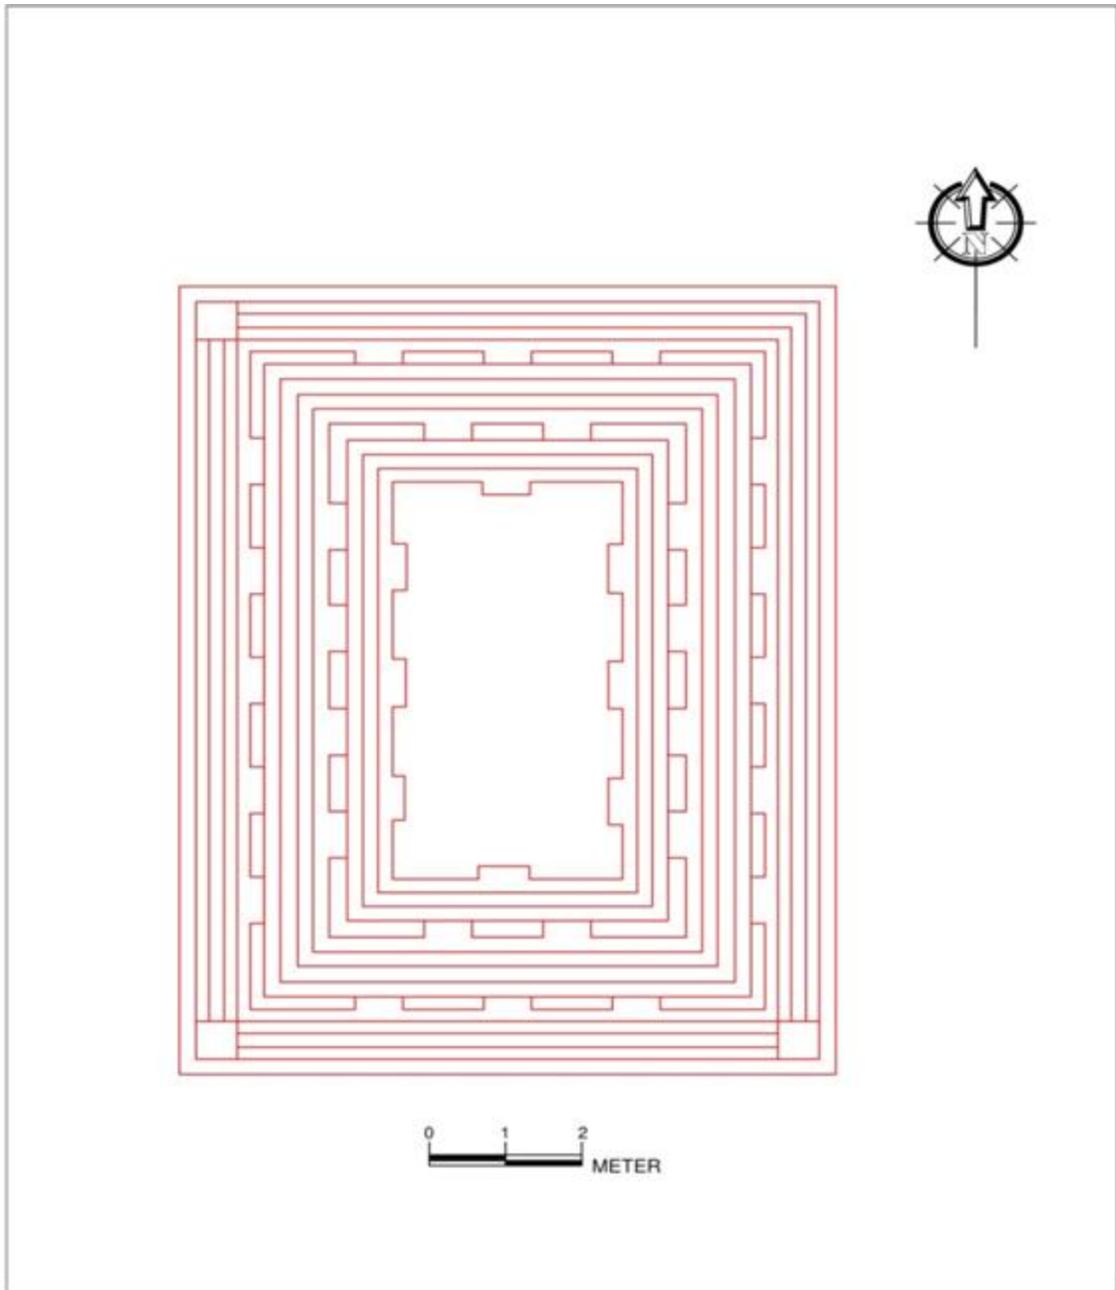
Fig. 19

Plan of Manikarnika Kund, Varanasi

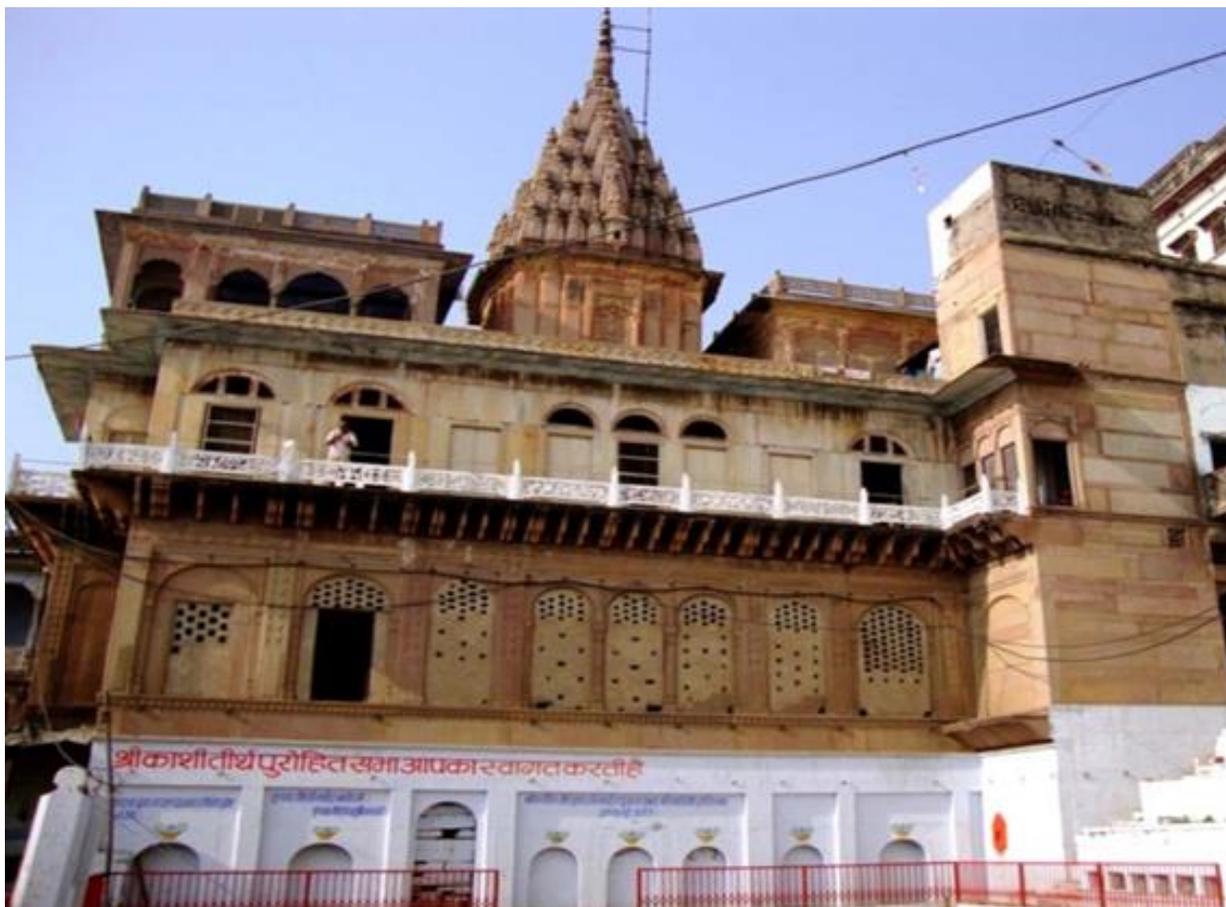
Plate 54

Varanasi: north elevation of Alwar Mandir at Manikarnika Kund

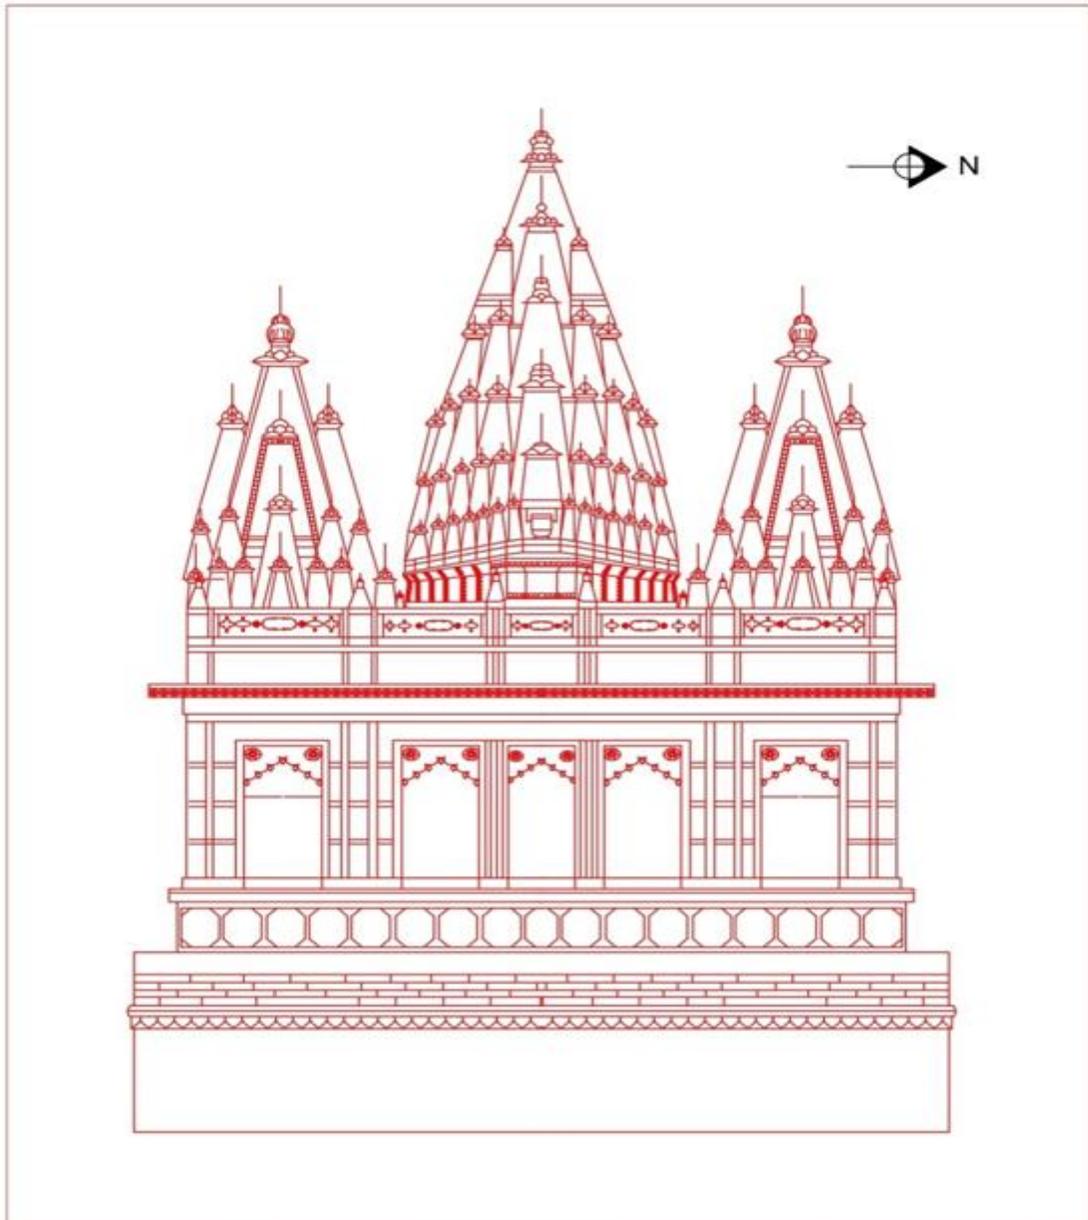
Fig. 21

Varanasi: front elevation of Assi Mahadev Temple, Assi Ghat

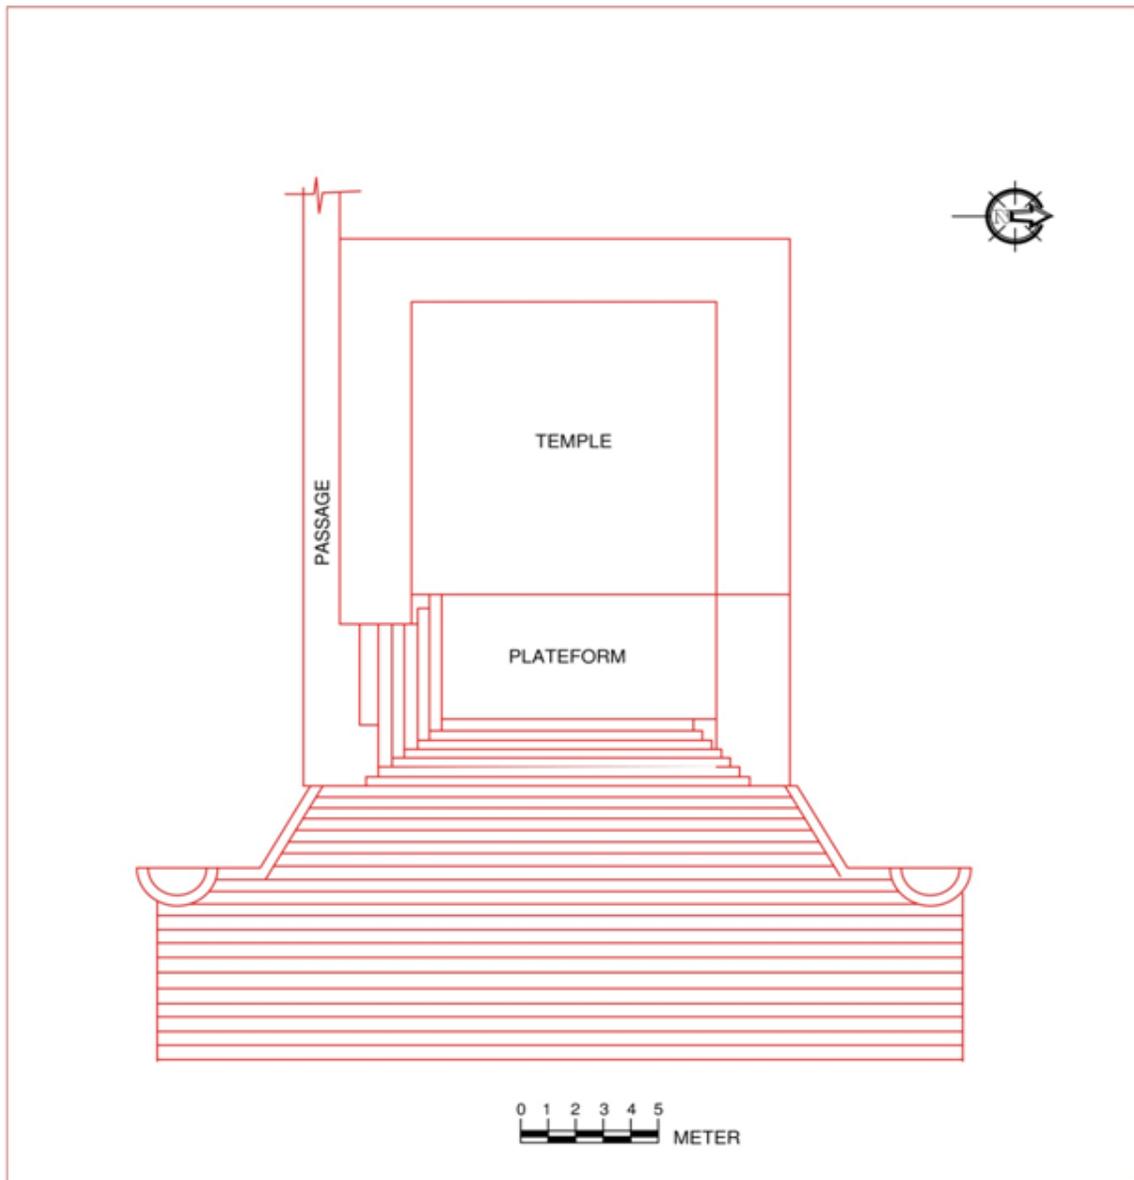
Fig. 22

Varanasi: Plan of Assi Mahadev Temple, Assi Ghat

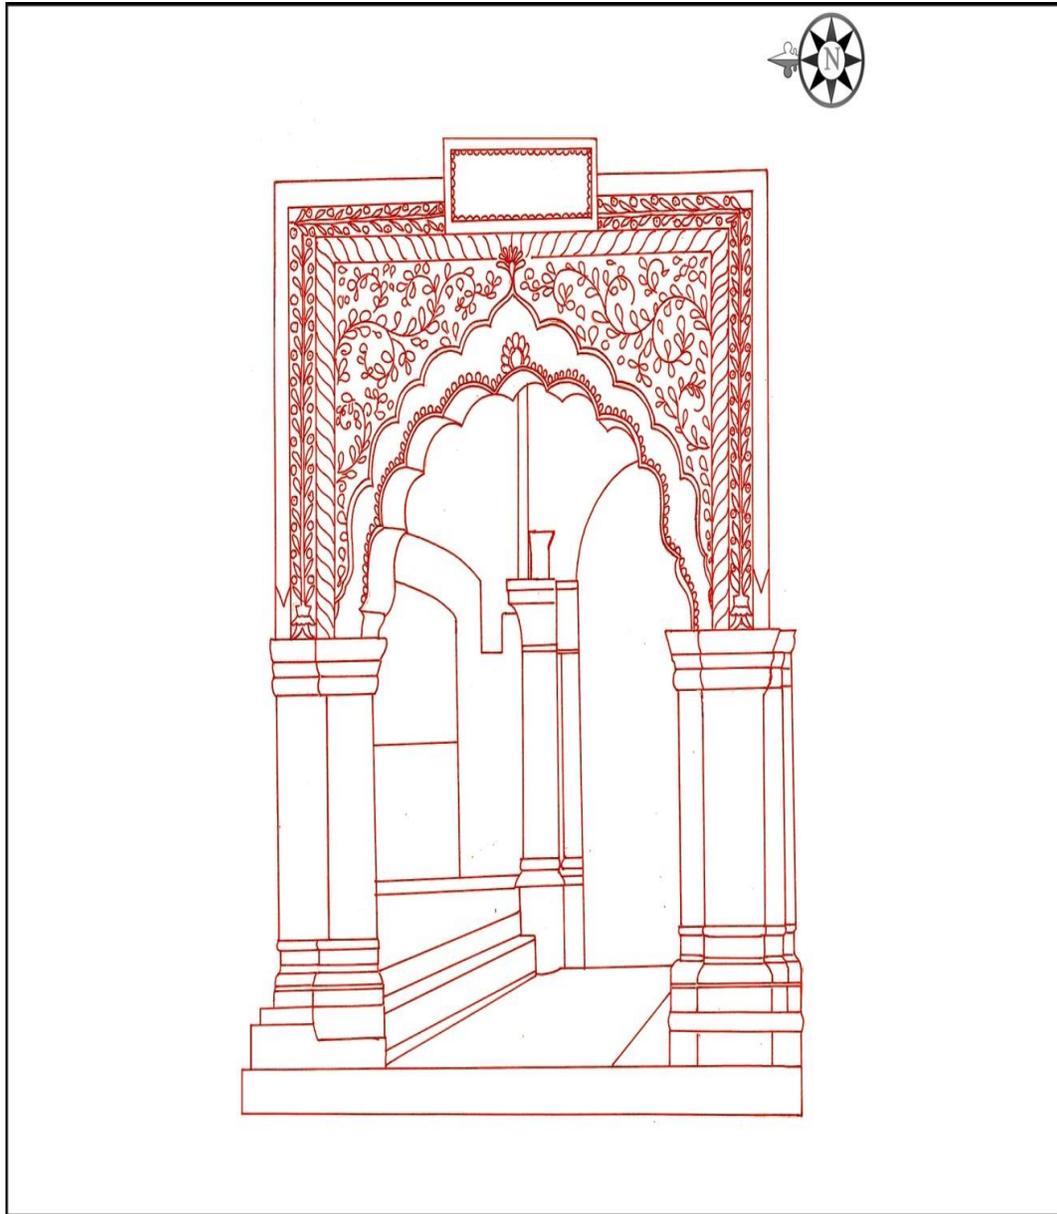
Fig. 23

Varanasi: Elevation of Main Entrance of Mahendravi Guest House

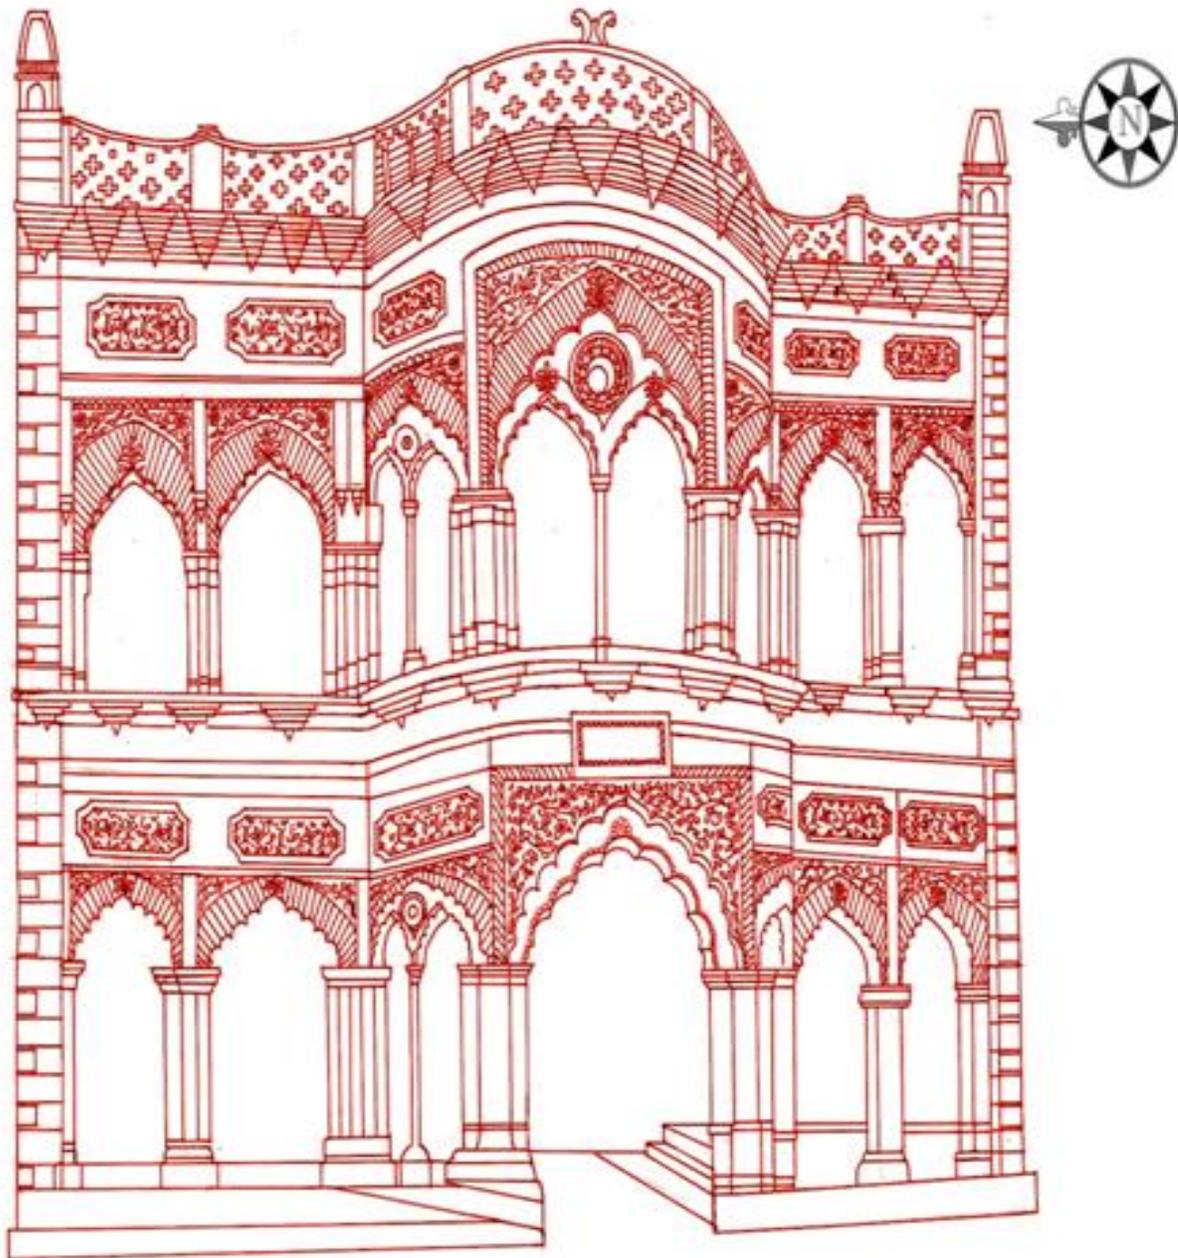
Fig. 24

Varanasi: front elevation of Mahendravi Guest House

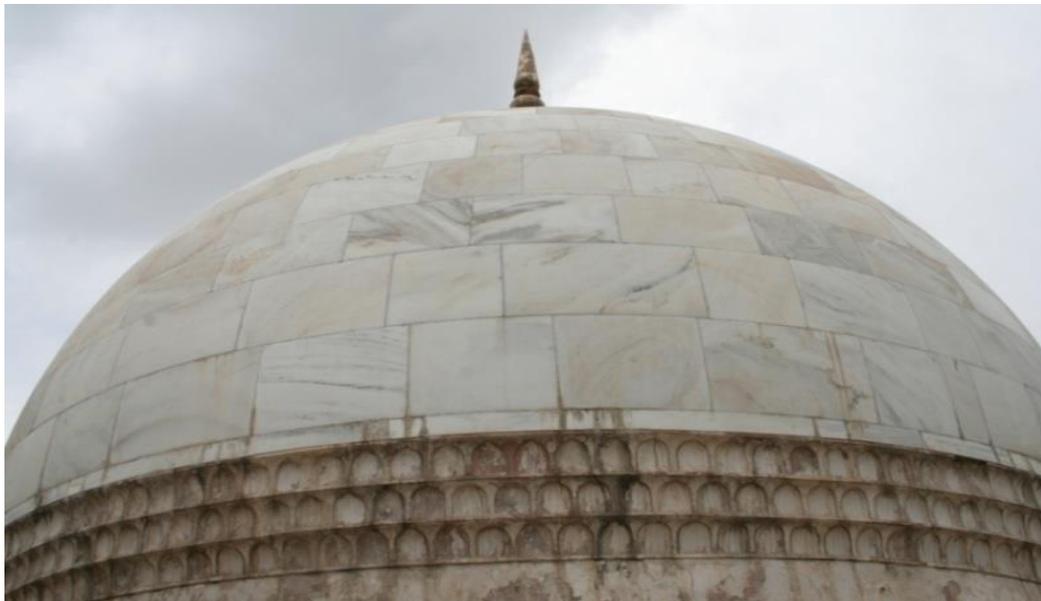
Aurangabad: A, Main dome of Bibi-Ka-Maqbara during and B, after repairs
