INDIAN ARCHAEOLOGY 2010-11 - A REVIEW

ARCHAEOLOGICAL SURVEY OF INDIA
JANPATH, NEW DELHI

INDIAN ARCHAEOLOGY 2010-2011 – A REVIEW

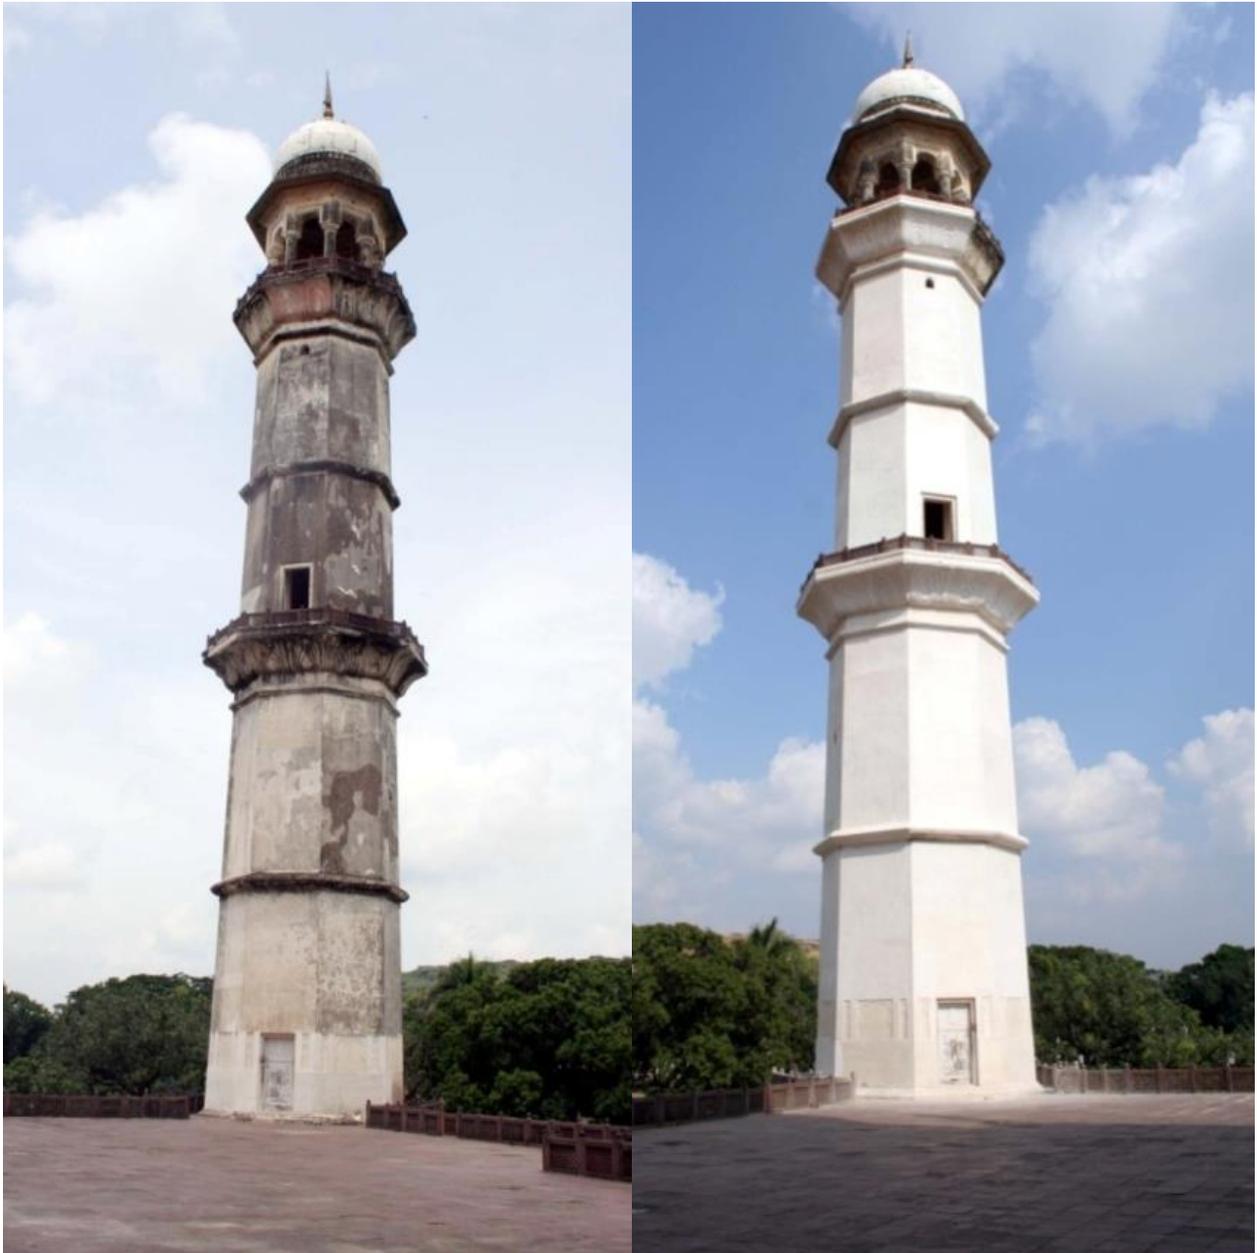
Plate 58

Aurangabad: A, Bibi-ka-Maqbara before and B, after repairing of the north-east minar

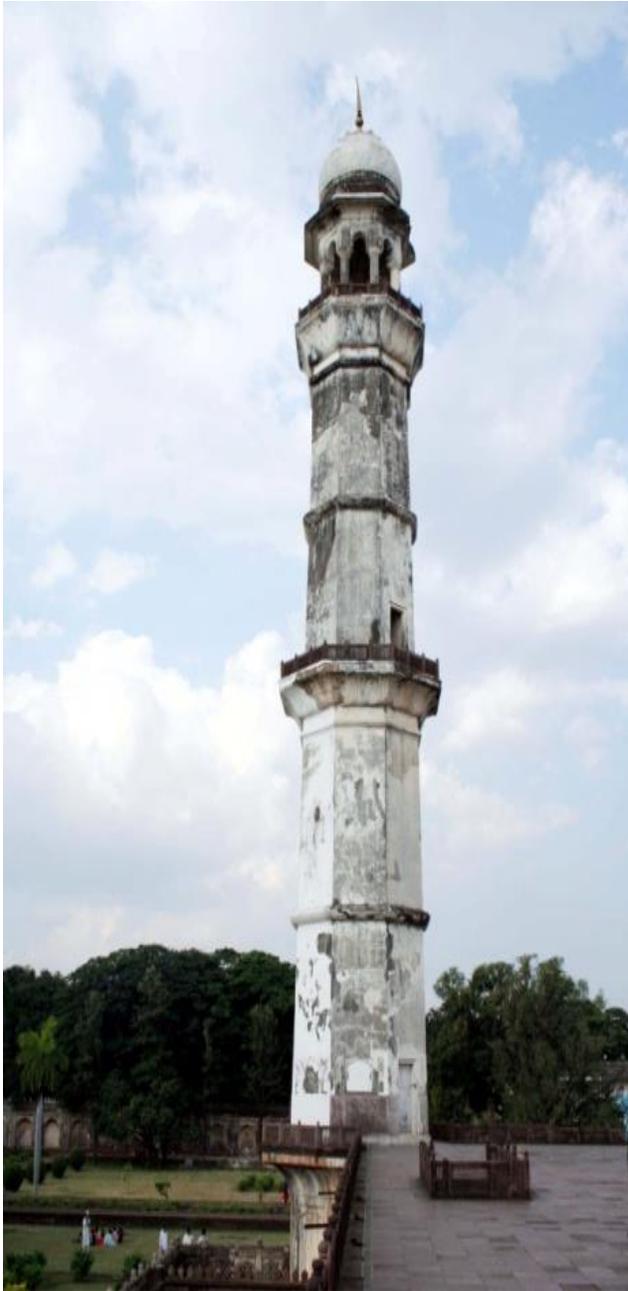
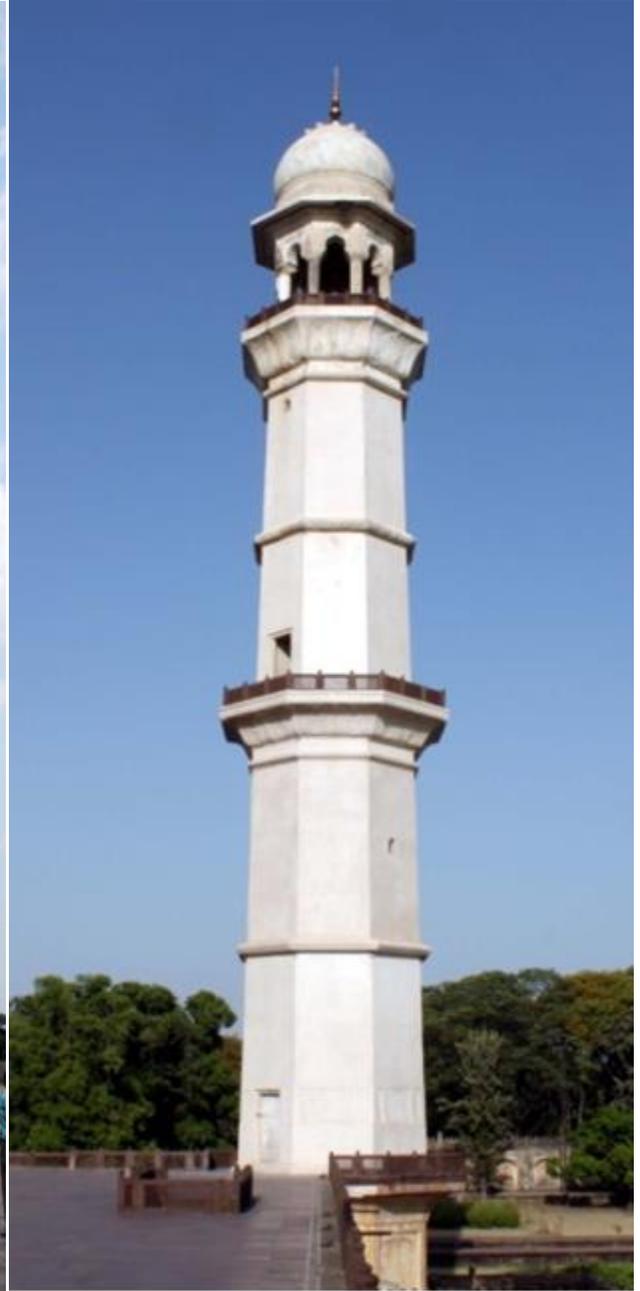
Aurangabad: A, Bibi-ka-Maqbara before and B, after repairing of the south-east minar

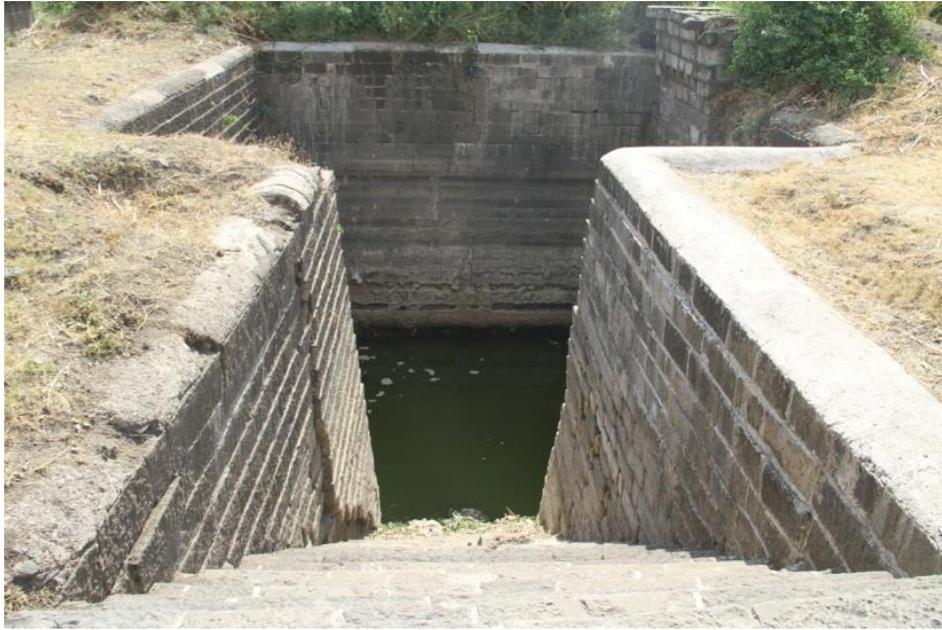
Ahmednagar: A, stepped well of Tomb of Nizam Ahmed Shah before and B, after repairing

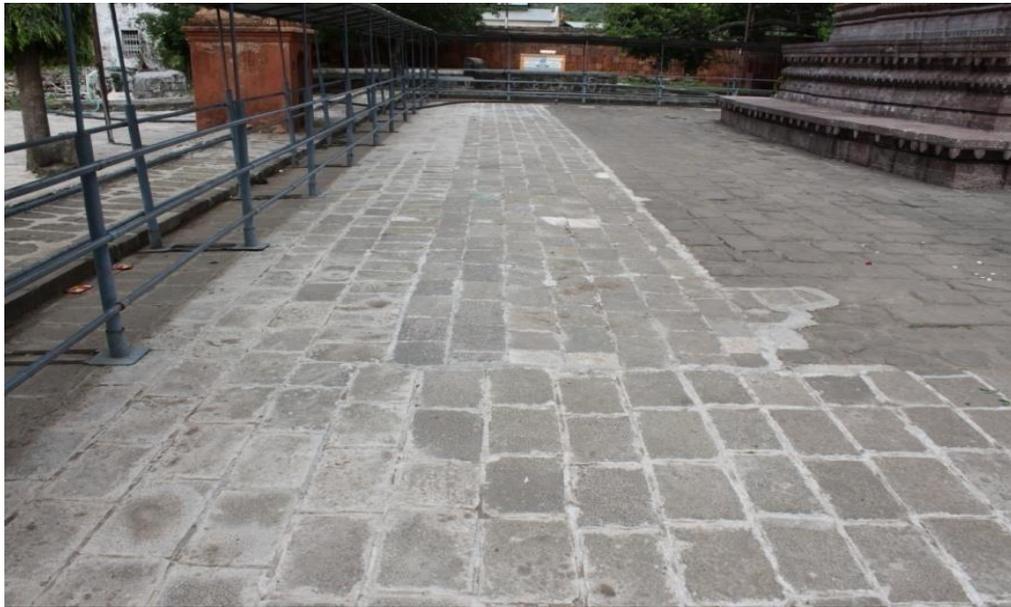
Ellora: A, before and B, after repairing of stone slab flooring at Ghrishneshwar Temple

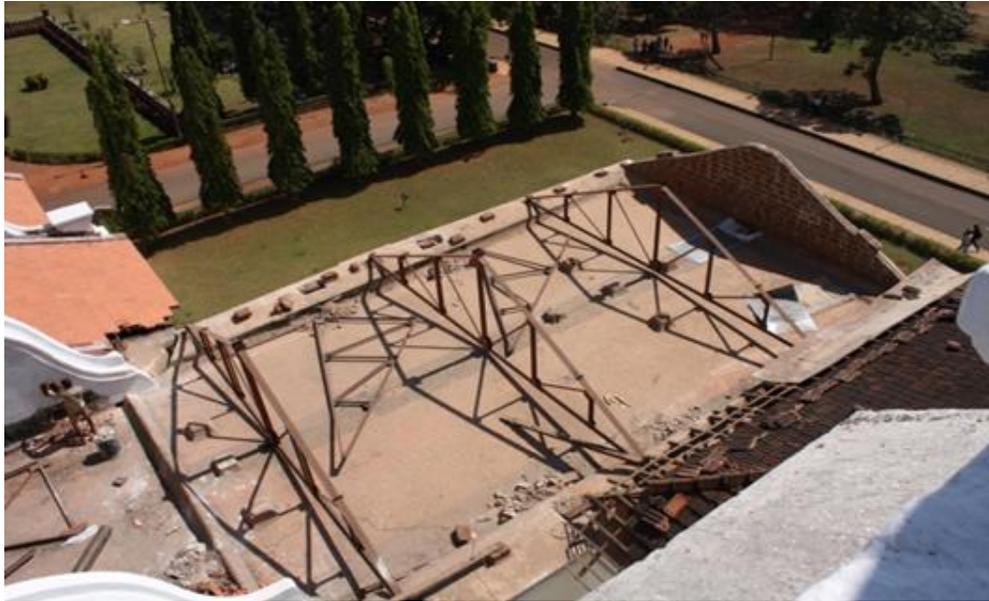
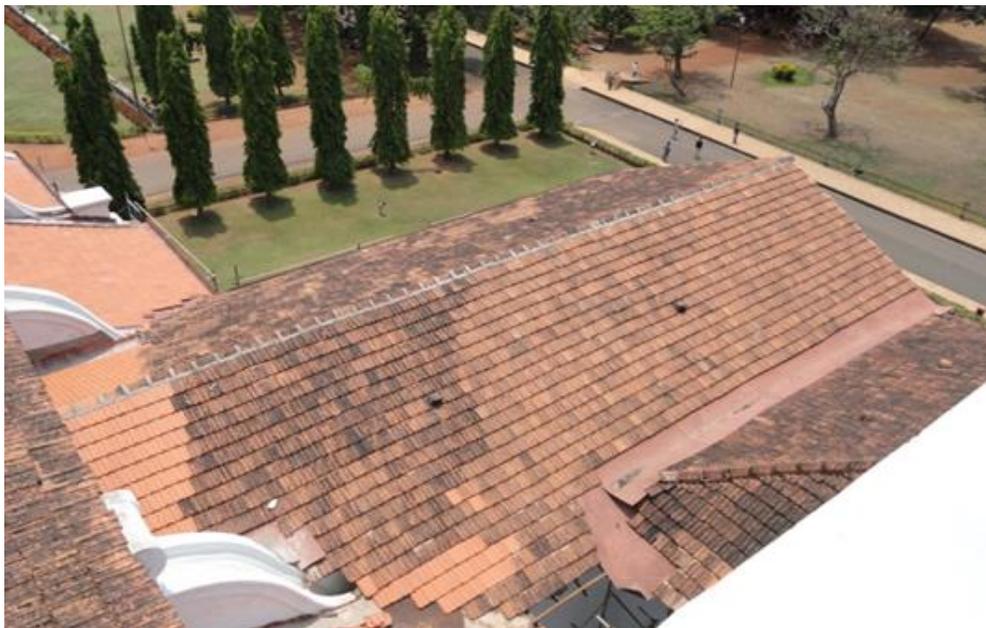
Se' Cathedral: A, during and B, after repairs of the roof of Blessed Sacrament

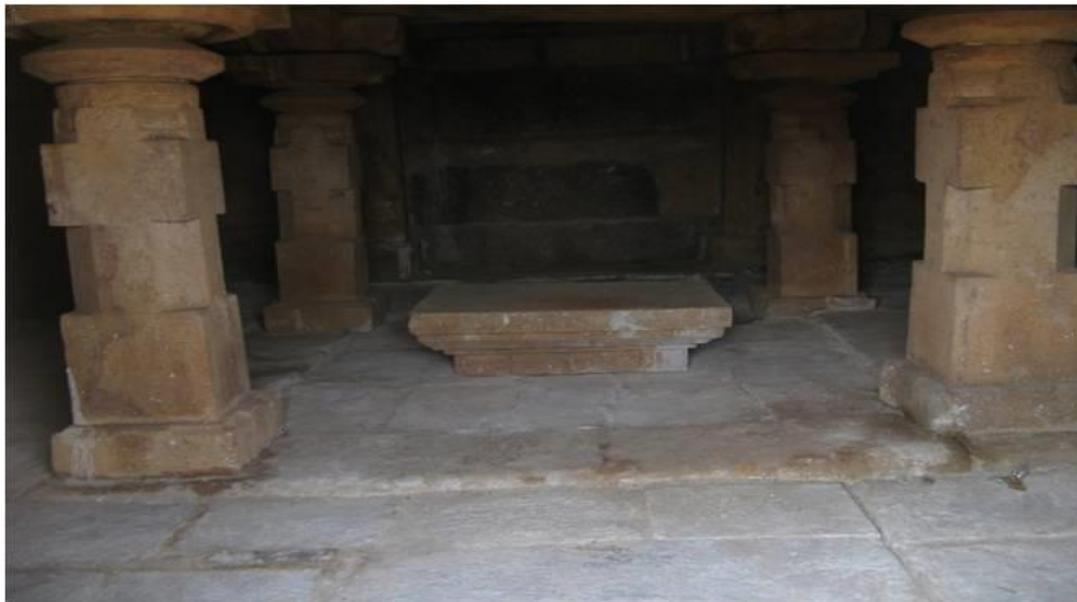
Mandapa towards s-w corner of Great Mosque at Gandikota: A, before and B, after repairs

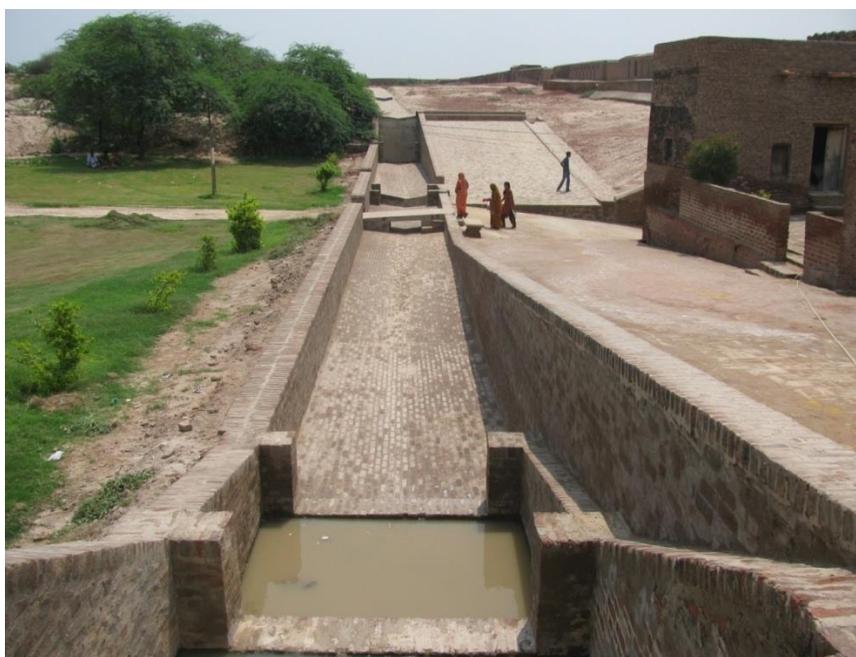
Bhatner Fort, Hanumangarh: A, before and B, after repairs to drains
